G01 (X3) up to and including November 13, 2017		
--	--	--

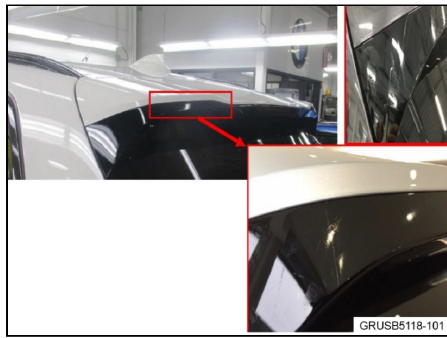
After removal of the transportation protective foil (Bodyguard), adhesive residue remains on the rear spoiler reinforcement piece as seen below.

The transportation protective foil (Bodyguard) extends too far onto the plastic lower spoiler reinforcement piece.

For the affected vehicles, replace the rear lower spoiler reinforcement piece.

Replace the lower section of the rear spoiler, following repair instruction **REP 51 71 417**.
