AIR DUCT COVER LOOSE OR MISSING

This Service Information Bulletin (Revision 1) replaces SI B51 02 21 **dated February 2021**.

E-Series	Model Description
F90	M5 Sedan

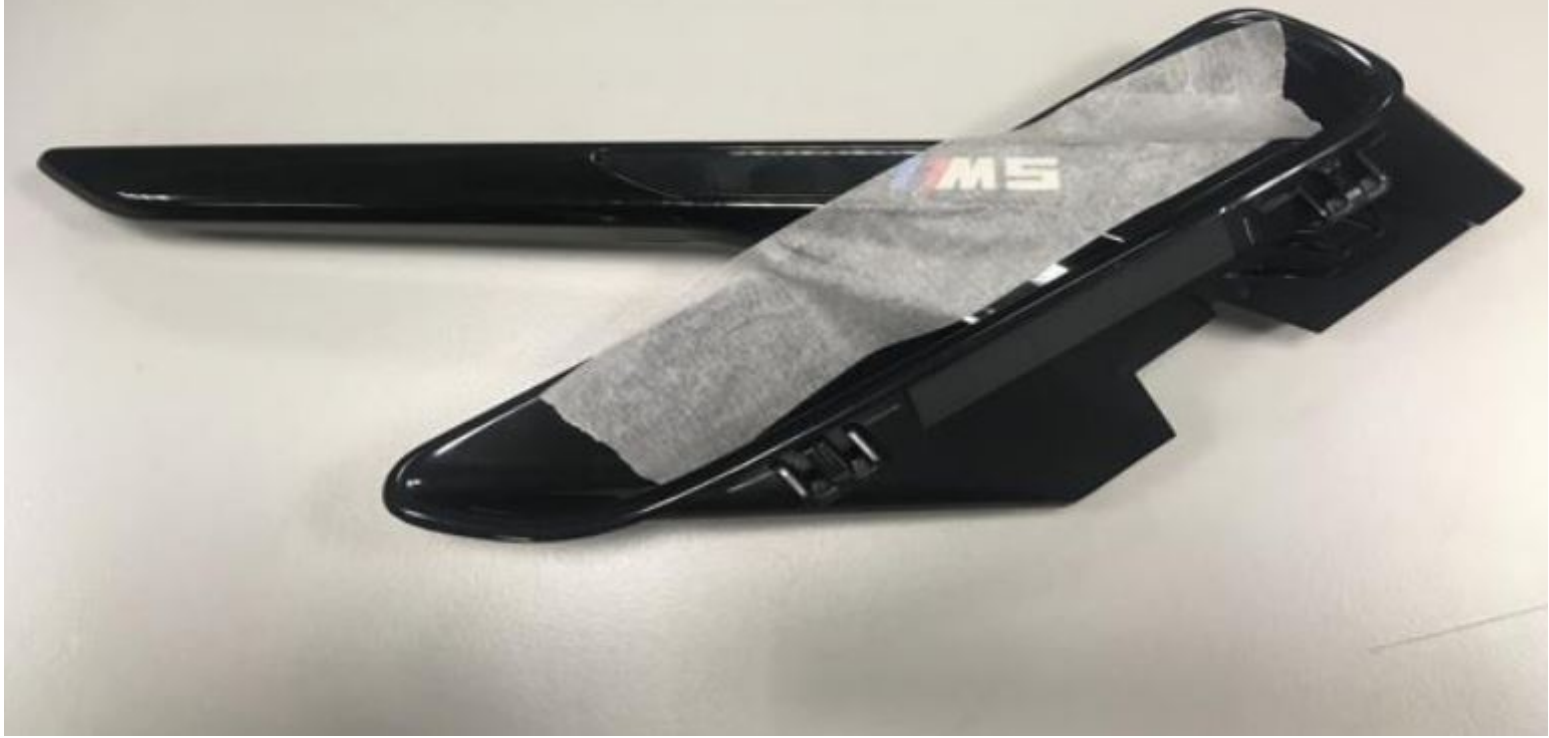
The air duct cover (fender mounted) may be loose or missing.

Prolonged high-speed driving can cause movements of the fender, causing the air duct to become loose.

1. Clean the fender in the area of the air duct mounting using a lint free cloth and cleaner R2 P/N 83 19 0 417 324. Allow at least 2 minutes for the cleaner to dry.
2. Using adhesive tape, secure the new air duct and air duct cover as shown below.
