This Service Information Bulletin (Revision 1) replaces SI B51 03 21 **dated February 2021**.

E-Series	Model Description
G20	3 Series Sedan

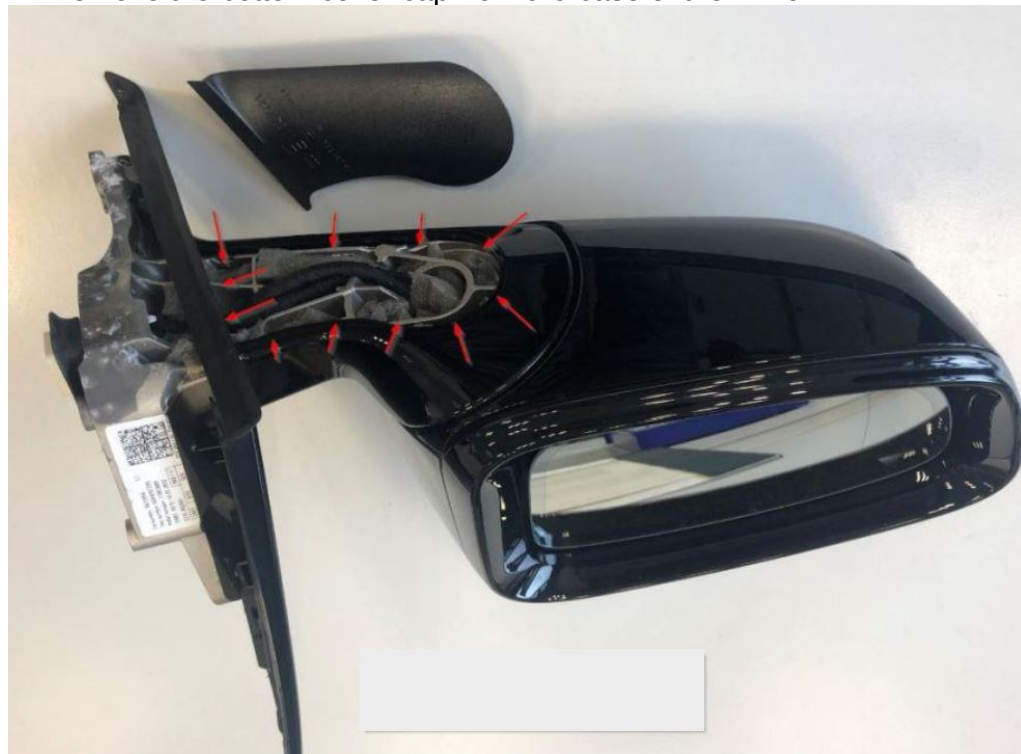
A ticking noise is present in the A-pillar and side mirror area when driving at speeds of approximately 40 MPH. This can occur on either side of the vehicle.

Wind entry into the side mirror housing can cause components inside the side mirror to vibrate.

1. Remove the exterior mirror on the affected door(s) following ISTA repair instructions "**REP 51 16 001 Removing and installing the outside rearview mirror on left or right front door**".
2. Remove the bottom cover cap from the base of the mirror.

3. Using Drei Bond P/N 07 58 9 062 376, apply a thin bead of adhesive around the bottom cover opening at the arrows shown above.
4. Reinstall the bottom cap and allow to dry.
5. Reinstall the side mirror.
