MODEL

F48 X1 (xDrive 28i)	Produced to March 30, 2015
---------------------	----------------------------

Customer can see a crease in the upper steering column joint trim, especially when moved into the lower position.

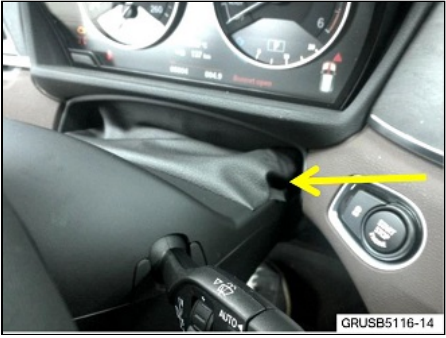
Tensioning of the upper steering column joint trim

<div>1. Confirm the upper joint trim is creasing.</div> <div>2. Use Repair Instruction 32 31 003 to replace the steering column joint trim.</div>
---	---

Replace joint trim.
