FUEL FILLER DOOR STICKING

This Service Information Bulletin (Revision 1) replaces SI B51 05 20 **dated February 2020**.

E-Series	Model Description
G06	X6 Sports Activity Coupe
G07	X7 Sports Activity Vehicle

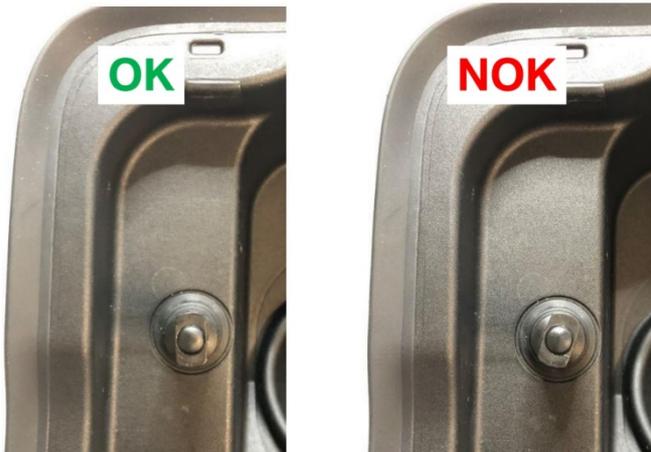
1. Open the fuel filler door to inspect the orientation of the fuel filler door ejector.

Ensure the ejector is positioned straight up and down as shown to the left.

Is the ejector OK as shown to the left?

No: Replace the complete insert (aka cover pot) and continue to step 3.

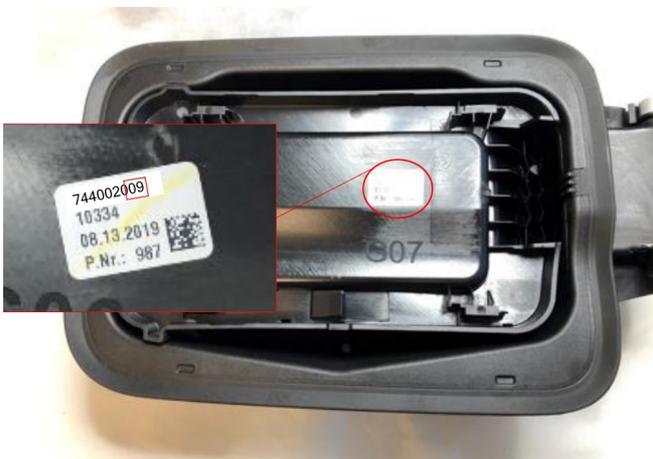
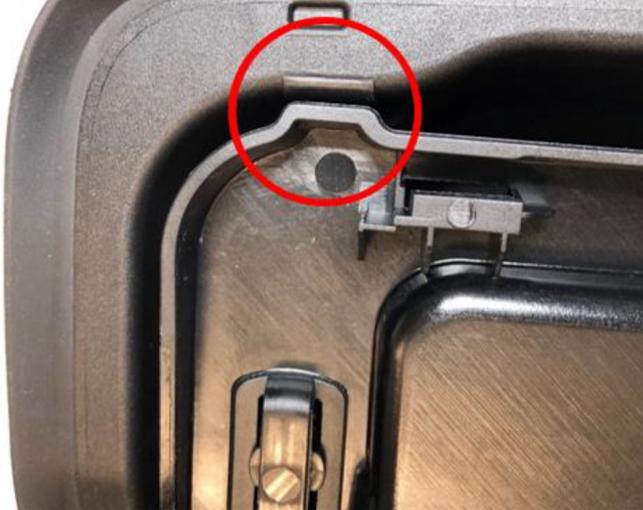
3. This is the area which will be modified

(circled). Do not modify the lower tab, only the upper.

4. Remove 0.7 mm from the upper tab (arrow) using a file. A feeler gauge can be used (shown lying flat along top edge) to assist with measuring.

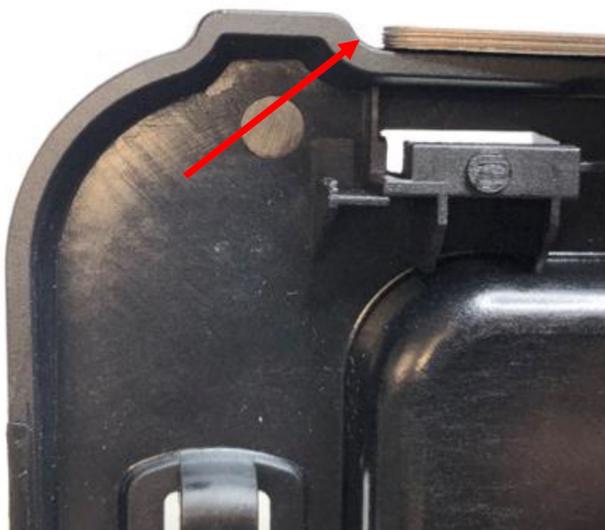
5. Close the filler flap and measure the distance between the upper tab and the filler door assembly. The gap must be at least 0.1 mm.

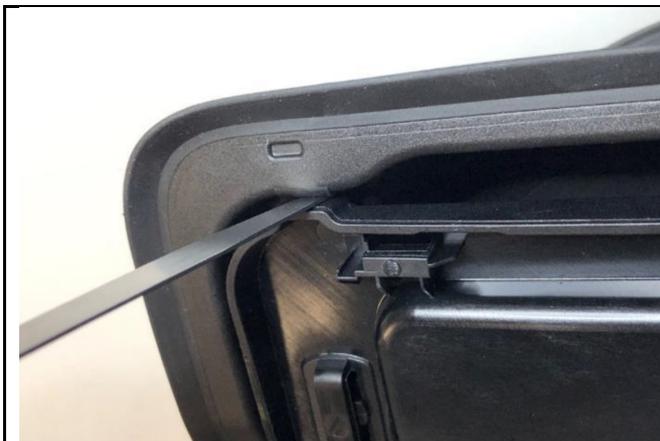
6. Open the filler door to measure the slotted opening of the filler flap as shown to the left.

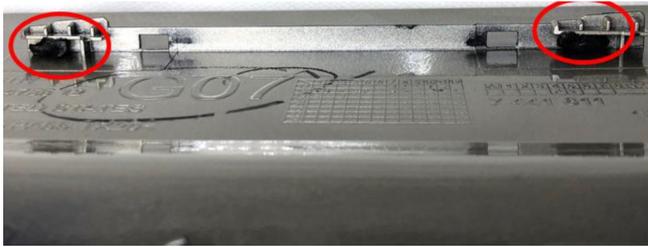
9. The photo to the left shows correct installation of butyl.
