## STREAKS ON FRONT SIDE WINDOWS

This Service Information Bulletin (Revision 1) replaces SI B51 06 21 dated March 2021.

E-Series	Model Description
G22	4 Series Coupe
G23	4 Series Convertible
G82	M4 Coupe

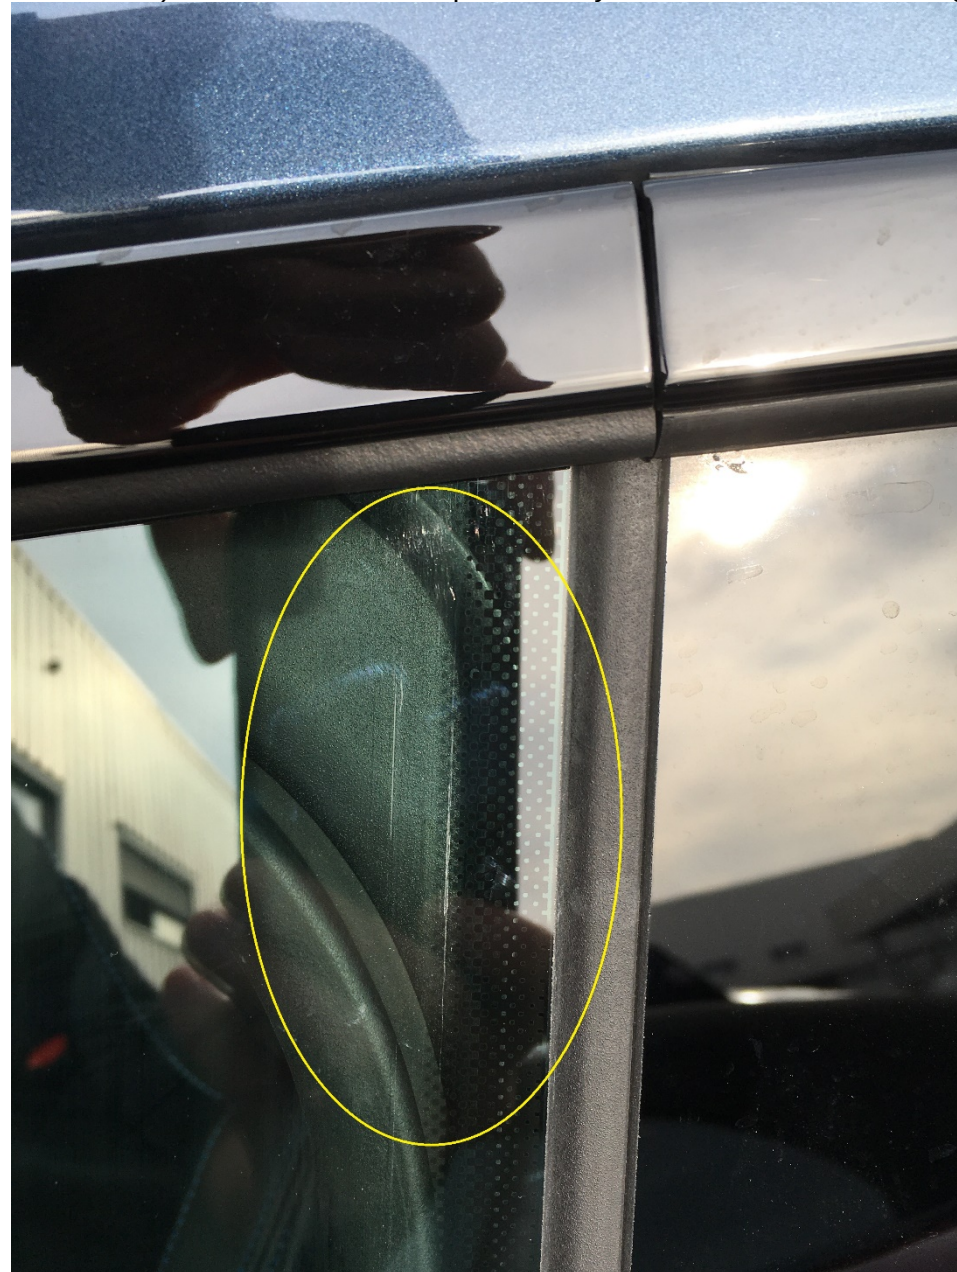
Streak marks are visible, most commonly on the upper rear corner of the front side window (circled below; driver's side shown). The marks can be present anywhere on the rearmost edge of either front window.

The inner window channel may be rubbing against the window glass.

Rework the inner window guide.

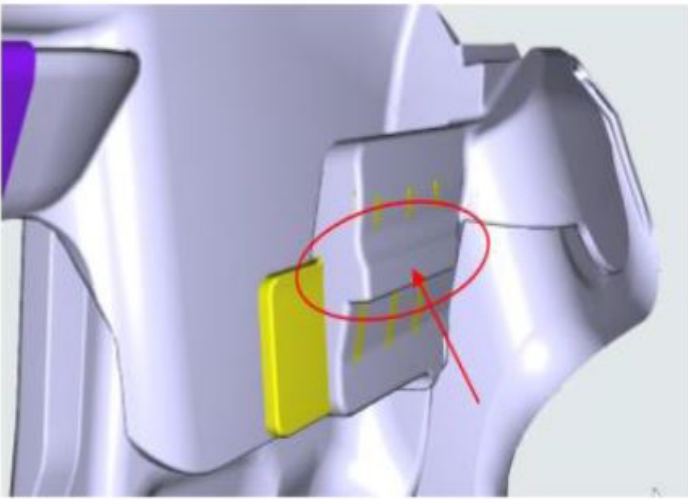
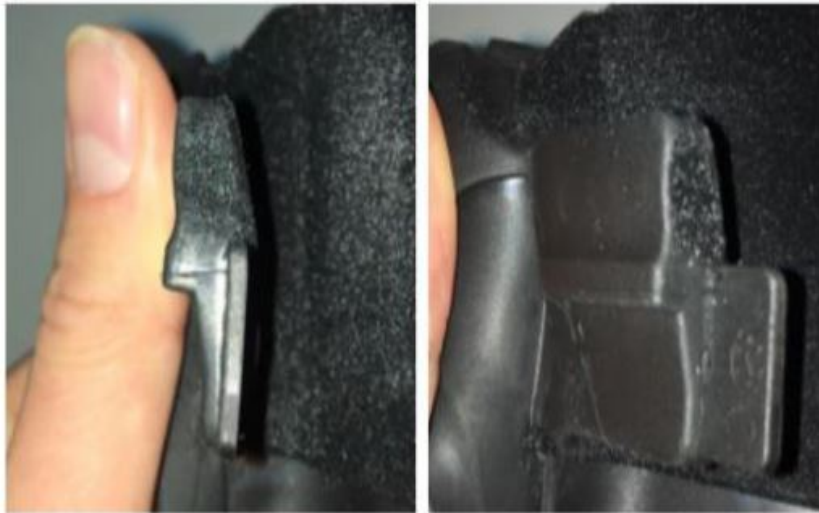
2. Identify the area of the seal shown below. Note the sharp plastic edge of the seal. This sharp edge is the cause of the streaks.

3. Using a file, carefully remove and smooth the sharp edge from the plastic guide. The photo below shows an example of how the guide will look after rework.
