GROANING OR CRACKING NOISE WHEN OPENING OR CLOSING THE DOORS

E-Series	Model Description
G30	5 Series Sedan
G32	640i xDrive Gran Turismo

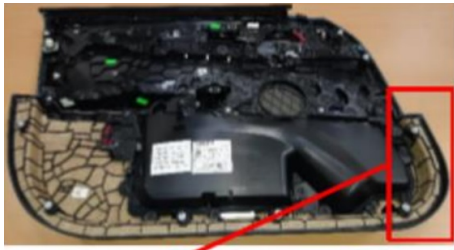
1. Remove the door panel of the affected door following ISTA/AIR repair instructions for the specific door affected.
2. Cut a strip of noise reduction tape, P/N 51 41 8 170 727 to a length of 100 mm (approx. 4 inches).

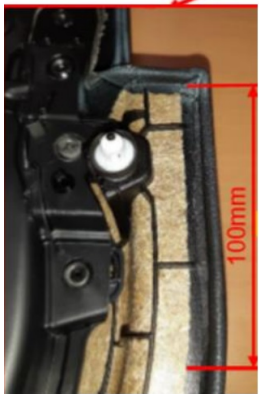
3. Apply noise reduction tape in the area shown to the left.

Note: Ensure the tape is only applied to the edge and inside of the door panel so that it is not visible from the outside.
