## WHISTLING NOISE FROM FRONT BUMPER

E-Series	Model Description
G20	(3 Series Sedan)

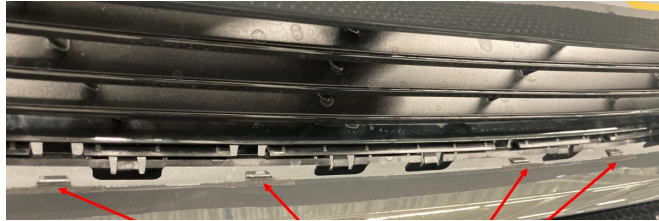
Whistling noise is heard coming from the front bumper while driving at highway speeds.

The noise is caused by the bottom clips of the lower grill. (As shown in the photo)

Place felt on the lower clips of the bumper.
