G01 (X3) produced up to 6/1/2018			
----------------------------------	--	--	--

When turning the steering wheel, a rubbing or scraping noise may be heard. This may only be heard with the steering wheel adjusted to the highest or lowest tilt positions.

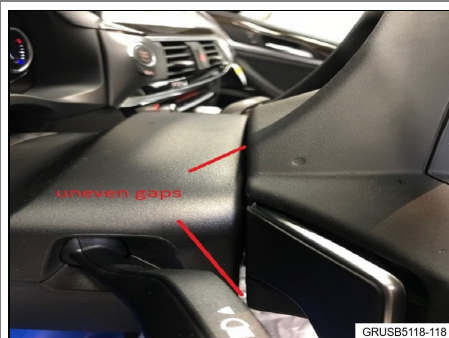
1. Perform a visual inspection of the steering column shrouds.

Inspect for uneven gaps between the steering column shrouds and the steering wheel.

Do the gaps appear uneven as seen to the left?
