I15 (I8 Roadster)

A creaking noise may be present in the B-Pillar area at the side window seal while driving on rough road surfaces.

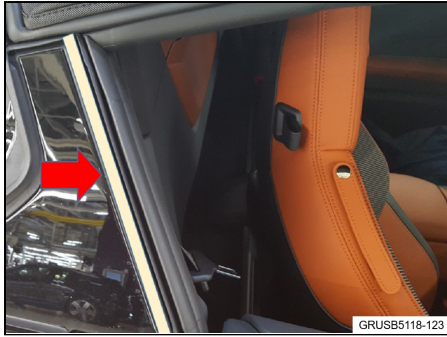
The window is rubbing against the side window seal at the B-Pillar.

Clean and lubricate the side window seals. Even if the noise is only present on one side of the vehicle, perform this repair on both sides.

1. Clean both side B-Pillar window seals using warm water and a lint free cloth. Ensure the seals are dry and clean.

2. Apply a light coating of rubber care, using PN 83 19 2 449 390 Gummi Pflege rubber care fluid, to the seals in the area shown in the photo to the left.
	3. Clean excess lubricant from the window seals and ensure noise is no longer present.
