Model

G01 (X3)	G02 (X3)		
Produced 8/1/2018-8/27/2018	With option code 493 Storage compartment package

Situation

The support strap used to secure the luggage compartment cover in the raised position may be missing.

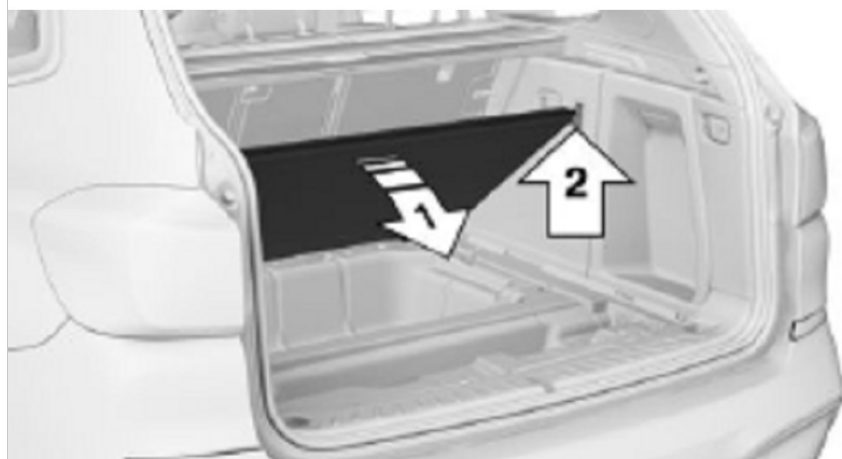
GRUSB5119-105

The incorrect luggage compartment cover may have been installed during production.

1. Inspect the luggage compartment cover at location "2" shown below.

Is the support strap installed on the underside of the luggage compartment cover?

Inspect and replace the luggage compartment cover if necessary.

1. Install the correct luggage compartment cover outlined in the parts information section of this bulletin following repair instructions 51 47 102 "**Removing and installing/replacing the luggage compartment floor covering**".
