E-Series	Model Description
G20	3 Series Sedan
G29	Z4 Roadster

Interference noises (creaking, groaning, clicking) may be present when folding the side view mirrors in or out.

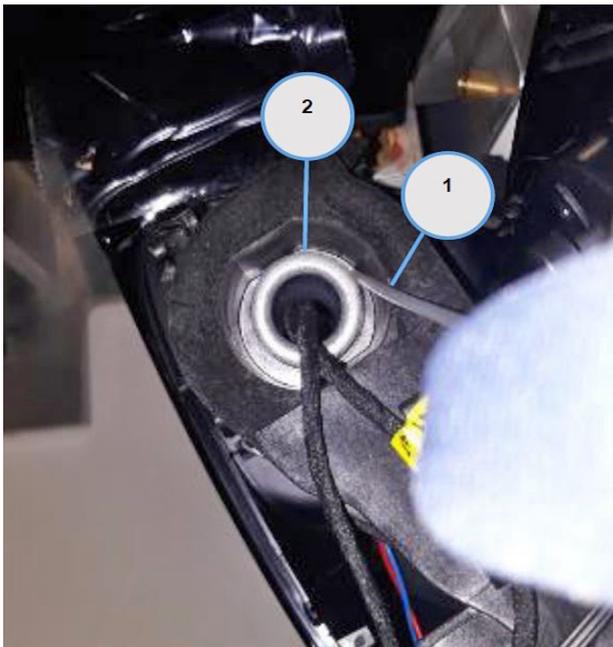
Excessive friction on the pivoting mechanism of the side view mirror hinge.

2. Using special lubricant, P/N 83 19 9 408 523 (1), apply lubricant to all visible surfaces of the sliding disc (2) as shown.

Complete this procedure on both sides of the vehicle.

3. Completely reassemble the vehicle. After reassembly, fold and unfold both mirrors 10 times to facilitate proper lubrication.
