SERVICE ACTION: CHECK BADGE ON TAILGATE, REPLACE IF NECESSARY

E-Series	Model Description	Production Date
G22	4 Series Coupe	March 17, 2021
G23	4 Series Convertible	March 17, 2021
G82	M4 Coupe	March 17, 2021

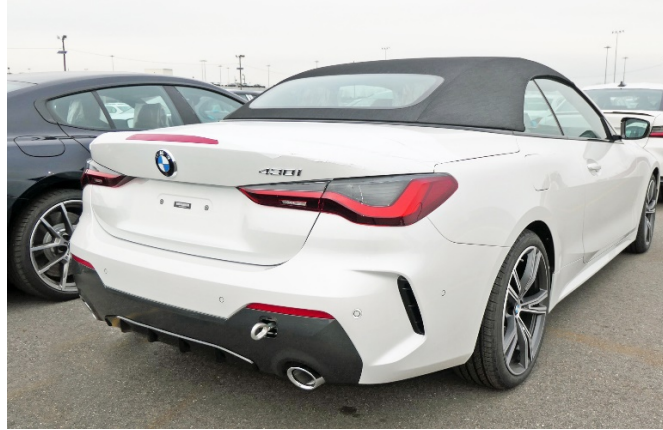
The "BMW" trunklid emblem (arrow) which contains the rear-view camera may not have been correctly fastened during vehicle production.

It is possible that the emblem & camera may become detached from the vehicle, such as when going through an automated car wash.

The badge may not have been properly installed.

Check the attachment of the emblem. Replace if needed.

- Apply a light force between the trunklid and the emblem.
- If the emblem cannot be moved by applying slight force, the emblem can remain on the vehicle.
- If the emblem lifts off the trunklid, the emblem must be removed, and a new emblem must be attached.
 - See repair instructions "Removing and installing/replacing rear BMW badge", REP 51 14 010.

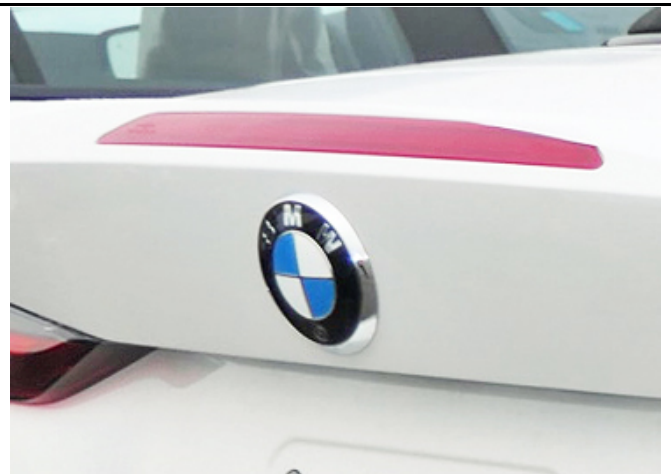
The rear-view camera is located at the "6:00" position (arrow).
