MODEL

G30 (5 Series Sedan)			
----------------------	--	--	--

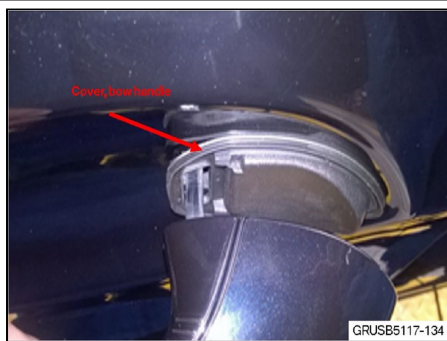
At highway speed, there is a fluttering wind noise coming from the area of the door handle; any door handle may be affected.

The bow handle cover is not properly sealed against the door.

After verification of cause, replace the bow handle cover.

1. Place adhesive tape over gap between the back end (the moving end) of the door handle and the door surface. Wrap tape all the way around this end of the door handle being sure to adhere the tape to the handle and the door surface.
2. Test drive vehicle.
 - **Was the noise still able to be heard?**
 - **YES-** continue standard diagnosis.
 - **NO** – replace the bow handle cover or mounting bell (driver's door).
