## MODEL

E82, E88 (1 Series) produced up to 3/2008

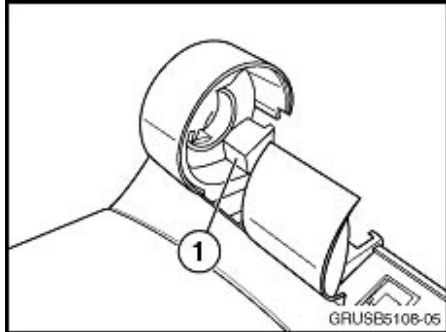
The limit stop on the armrest folding mechanism is not adequately damped.

5. Clean the vertical contact surface (1) to remove any grease that may be present. This should be done on both sides of the armrest.

6. Cut 2 felt strips to 10mm x 15mm.
7. Install 1 felt strip to each of the contact surfaces cleaned in step 5.
8. Apply Wurth Glide or a suitable alternative to the inside (concave) contact surface of the retaining springs.
9. Reinstall all components and ensure that the armrest moves up and down smoothly.
