### Trunk Lid Does Not Open Completely

This Service Information Bulletin (Revision 2) replaces SI B51 13 14 **dated December 2017**.

F30 (3 Series Sedan)	F31 (3 Series Sport Wagon)	F32 (4 Series Coupe)	F34 (3 Series Sport Wagon)
F80 (M3 Sedan)	F82 (M4 Coupe)	G30 (5 Series Sedan)

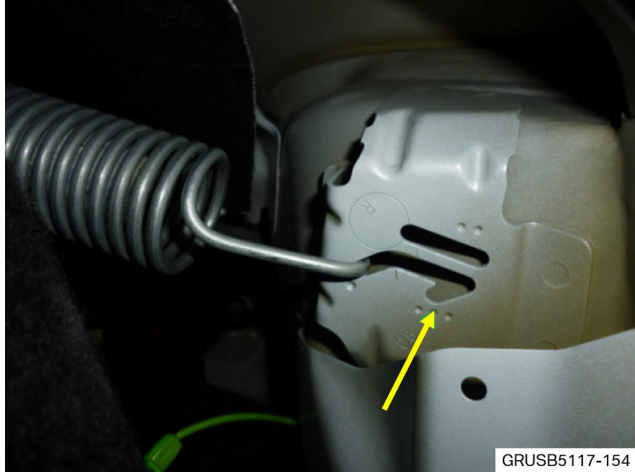
Incorrectly installed trunk lid tension spring may also not fully open a trunk lid.

5. Ensure the spring is attached to the

rearmost hook (shown by the arrow). If it is, continue troubleshooting, this bulletin does not apply.

If it is not, reattach it to the rearmost hook and retest.
