DOOR LATCHING COMPLAINTS IN COLD WEATHER

This Service Information Bulletin (Revision 1) replaces SI 51 13 19 dated April 2019.

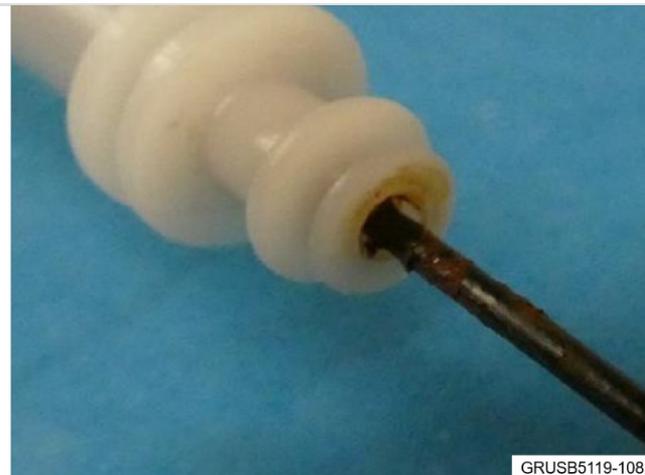
A leaking seal on the outer Bowden release cable may allow water to enter the cable sheathing and freeze.

1. Remove the outer Bowden cable on the affected door as per ISTA/AIR repair instructions.
2. Visually inspect the Bowden release cable for the outer door handle of the affected door(s).
 - Pull back the rubber seal (shown) to thoroughly inspect the cable sheathing for signs of corrosion or water droplets

Yes: Replace the affected Bowden cable, following ISTA/AIR repair instructions for the affected door.
