<b>E-Series</b>	<b>Model Description</b>
G20	3 Series Sedan

A rattle noise is present from the dashboard's center speaker cover. This may only occur during phone calls, or with certain volumes/tones of music.

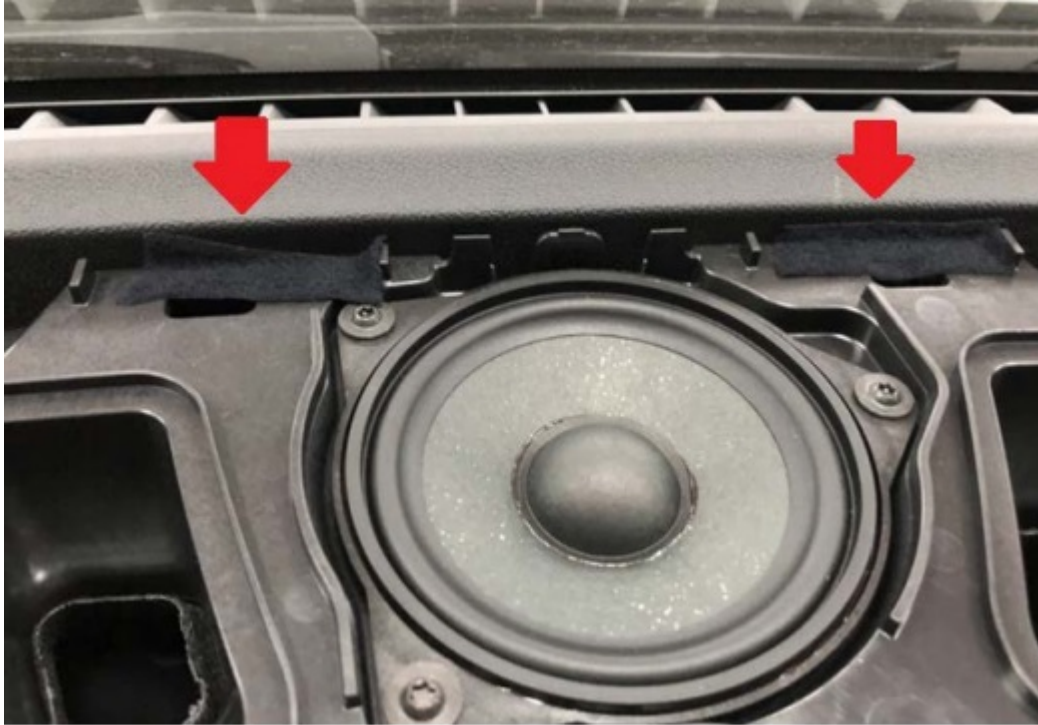
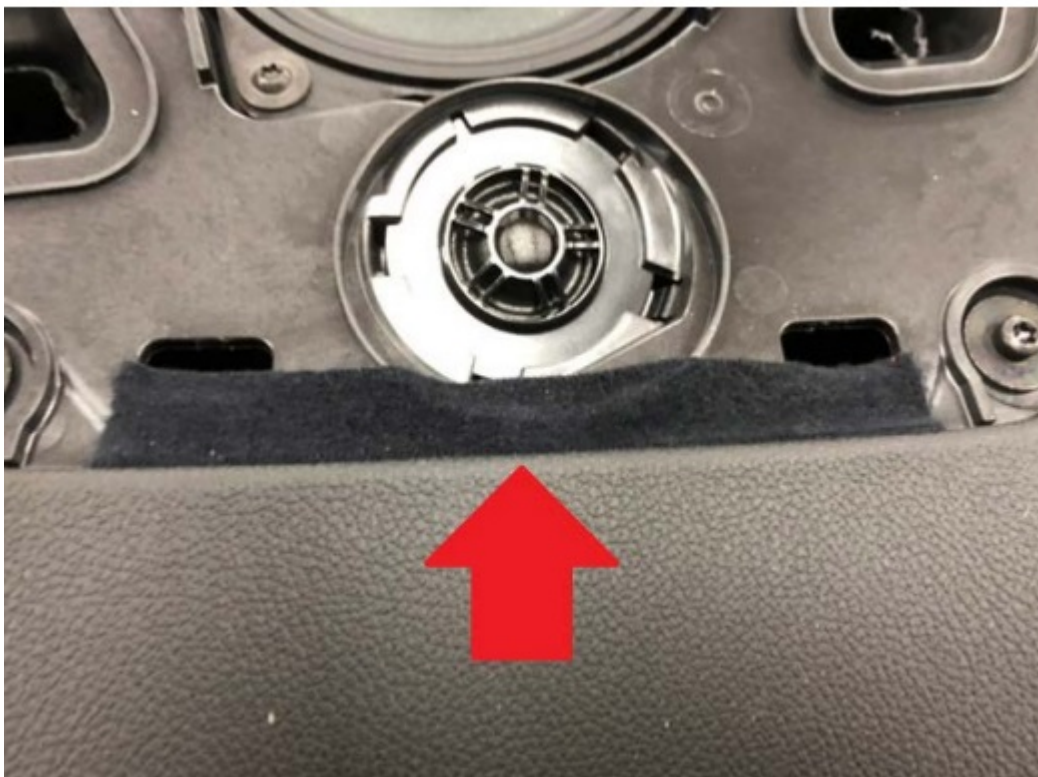
Interference between the dashboard speaker cover and the dashboard.

Insulate the speaker cover from the dashboard.

2. Apply any appropriately sized felt strips in the positions shown in the photo below:
