SERVICE ACTION: REPLACING BOTH SHAFT COVERS OF C-PILLAR TRIMPANEL

I15 (I8 Roadster)		
-------------------	--	--

Produced from 3/6/2018 to 6/7/2018

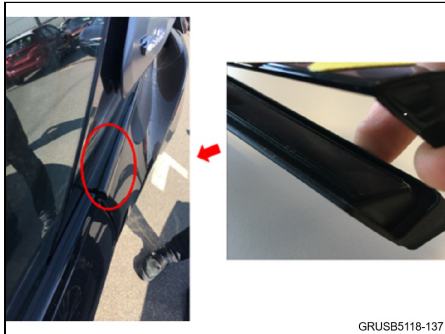
The rear window trim can gradually become detached, especially in high temperatures.

The window trim does not mount securely.

Replace both rear side window trim panels with updated parts.
