WIND NOISE FROM ENGINE BULKHEAD

This Service Information Bulletin (Revision 1) replaces SI B51 15 20 **dated April 2020**.

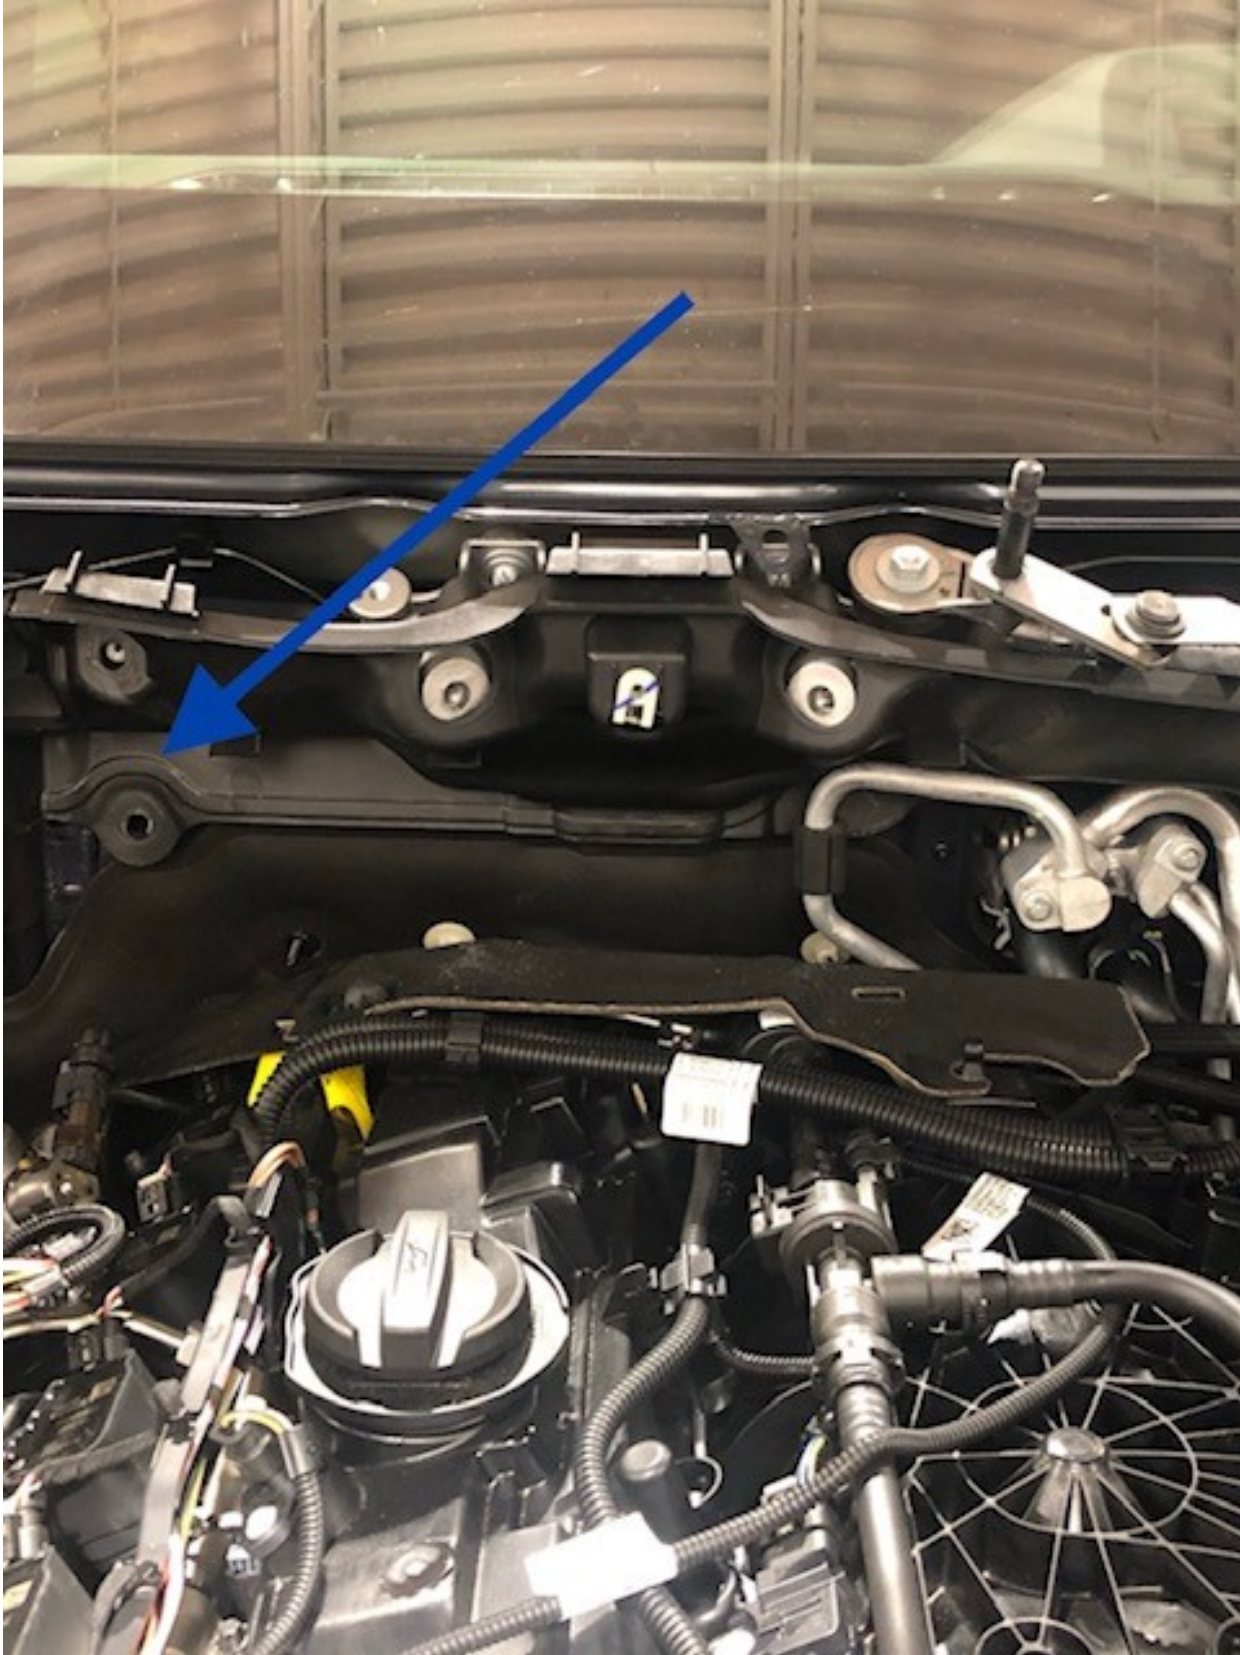
A wind noise can be heard when driving at highway speeds from the area around the lower windshield.

Improper sealing of the engine bulkhead trim.

1. Remove the engine bulkhead trim. Gain access for removal by removing the windshield panel cover, REP 51 13 116 "Removing and installing windshield panel cover".
2. Reference the photo below for the location of potential deformed seal:

3. With bulkhead trim removed, inspect the rubber sealing surface. Is the seal deformed?

Apply additional insulation to the engine bulkhead trim seal if found to be deformed.

4. Using butyl cord, reseal the bulkhead trim and completely reassemble the vehicle.
