E-Series	Model Description
G05	X5 Sports Activity Vehicle
G07	X7 Sports Activity Vehicle

A wind noise from the windshield area is present while driving, caused by a separation of the windshield side trim (circled) on one or both sides.

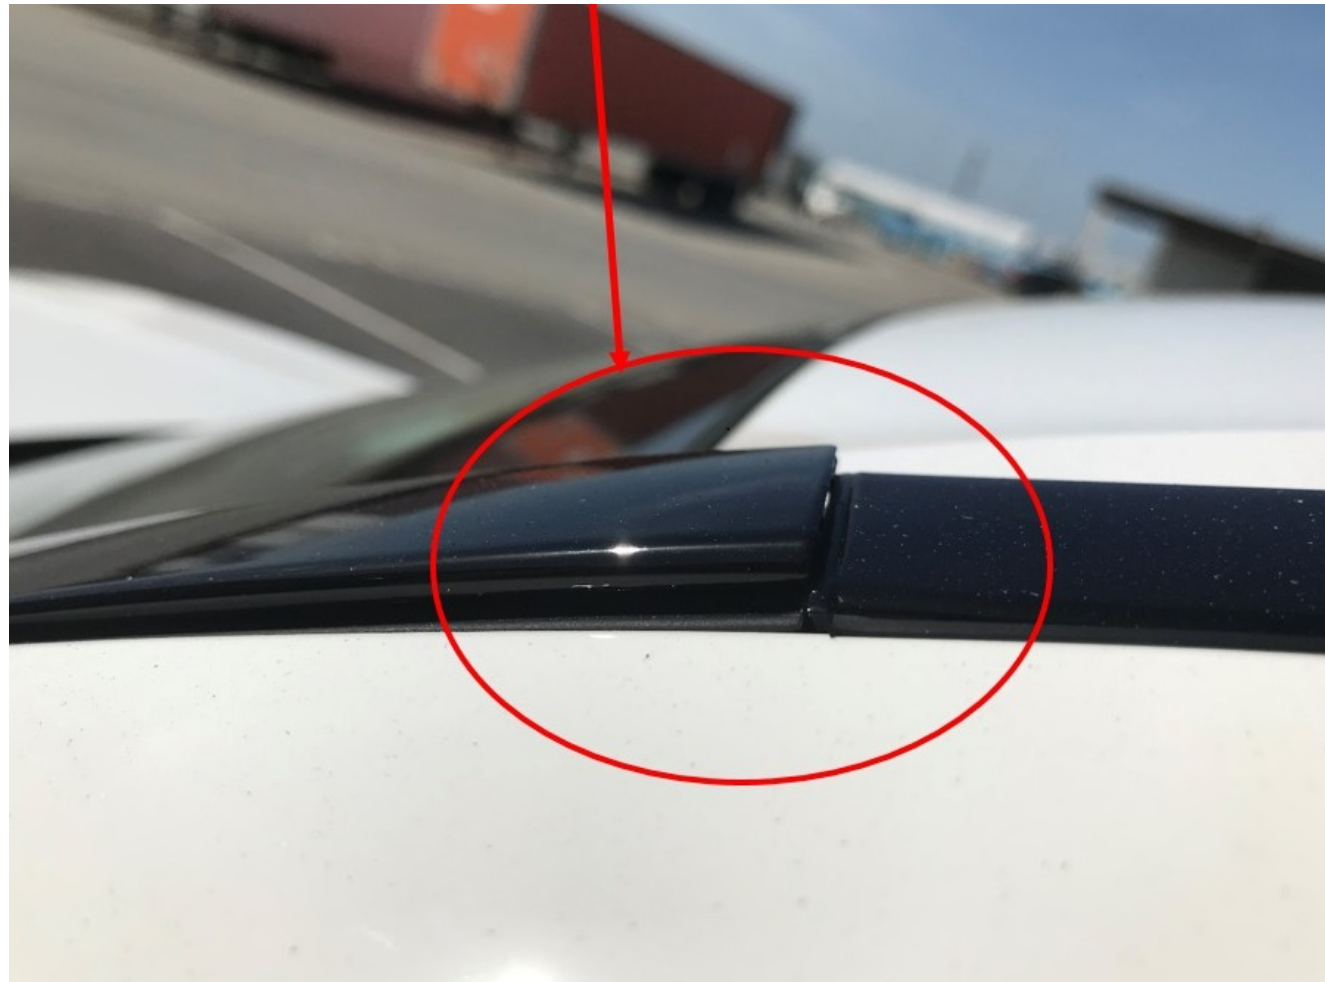
Improper bonding of the side windshield trim during production.

Replace one or both sides of the windshield trim.

Replace the affected side window trim following repair instructions REP 51 31 030 **“Removing and installing/replacing the gutter strip on the windshield on the left or right”**.
