E-Series	Model Description
G05	X5 Sports Activity Vehicle

The fuel filler flap is sticking when attempting to open or close, and may be visually misaligned.

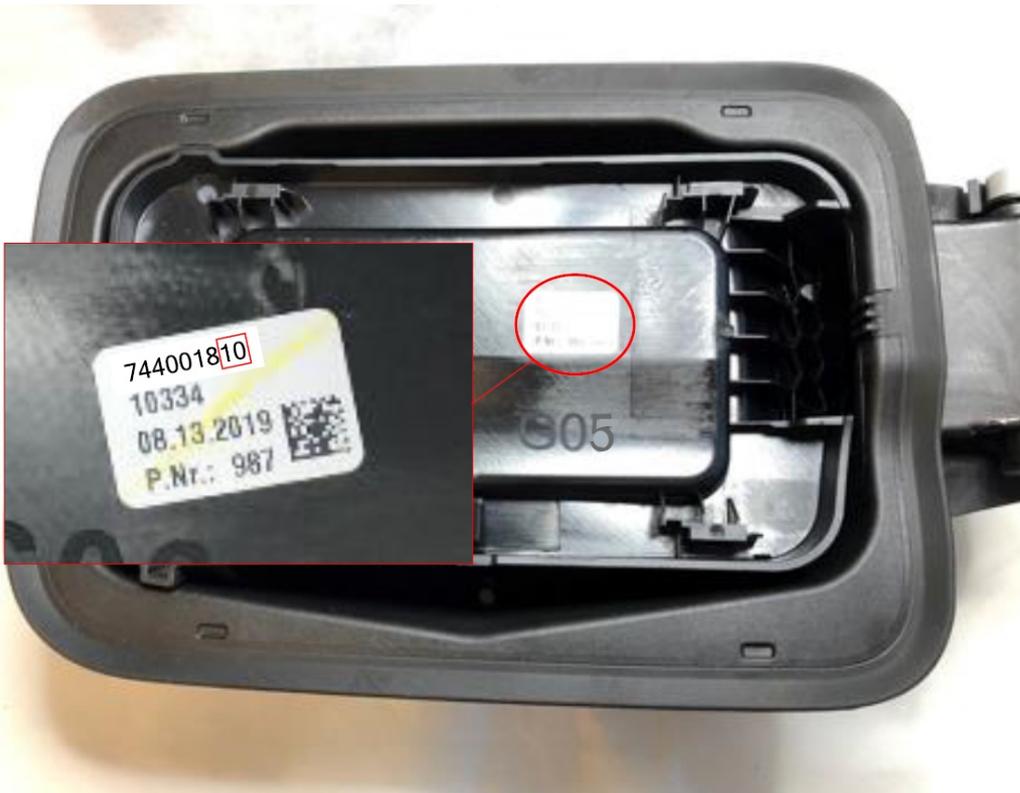
1. Remove the fuel tank filler flap following repair instructions **REP 41 63 000 “Removing and installing the fuel filler flap”**.
2. Inspect the white identification label shown below to find the part number and index.

- P/N 7440018 with an index below 11 requires replacement
- P/N 7440024 with an index below 9 requires replacement

Inspect and replace the fuel filler flap (aka cover pot, or cover bowl) if necessary.
