i12 (i8)

The steering column stalk switch for the turn signal sticks when actuating “headlight flasher” mode.

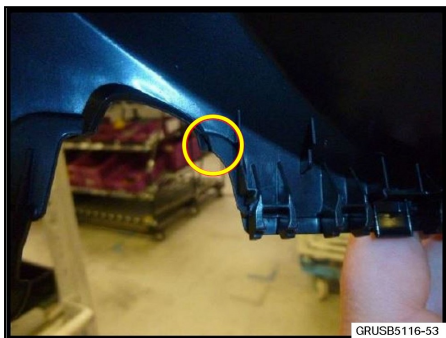
Interference fit between stalk switch and upper steering column shroud.

2. On the steering column shroud, rework the marked area.

Modify the marked area (approximately 5 x 5 mm) to look like the photo. Deburr and clean the worked location after material removal.
