MODEL

I8 (I12)

A loud cracking noise from the front door power window regulator occurs when opening or closing the right side or left side window.

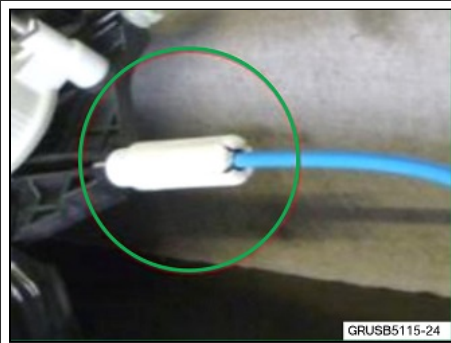
Inspect the cable housing of the front power window regulators. The picture shows a good cable housing. No black bushing is showing outside of the cable white housing.

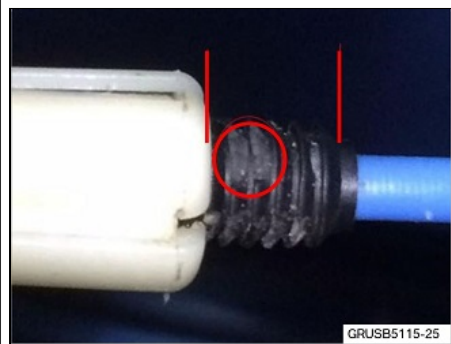
If the inspection of the cables shows damage to the black bushing, and it is extended out of the white cable housing, then replace the affected window regulator.

Refer to ISTA repair instructions 51 33 000 Remove and install/replace the power window regulator in the left or right front door.
