### MODEL

I15 (I8 Roadster)

There is a groaning noise from the A pillar area when opening or closing the doors.

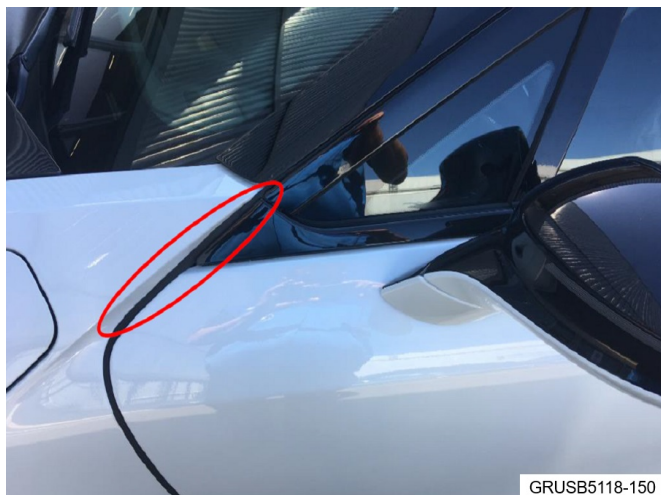
The A pillar seal is sticking to the door in the area shown below.

Condition the A pillar seals on both sides of the vehicle.

1. Clean the A pillar seals in the affected areas using only warm water and a lint free cloth.
2. Apply Gummi-Pflege rubber care fluid, PN 83 19 2 449 390 to the affected areas of the seals on both sides of the vehicle.
3. Retest to ensure that no noise is present.
