SQUEAKING NOISE FROM CENTER CONSOLE

E-Series	Model Description
F95	X5 M Sports Activity Vehicle
F96	X6 M Sports Activity Coupe
G05	X5 Sports Activity Vehicle
G06	X6 Sports Activity Coupe
G07	X7 Sports Activity Vehicle

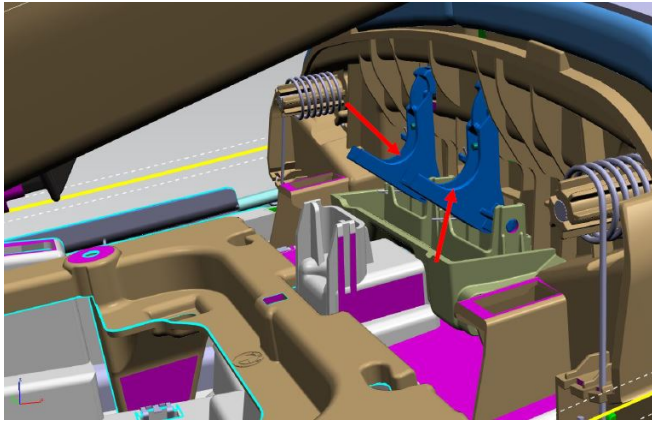
A squeaking noise is present when pressing the release button to open the center console.

Interference in the center console release mechanism.

2. Apply Krytox lubricant P/N 83 19 5 A4E 439 to the rounded side of the release mechanism as shown (arrows).
