MODEL

G12 (7 Series)

Rattle or vibration noises from door while driving on uneven surface after door replacement.

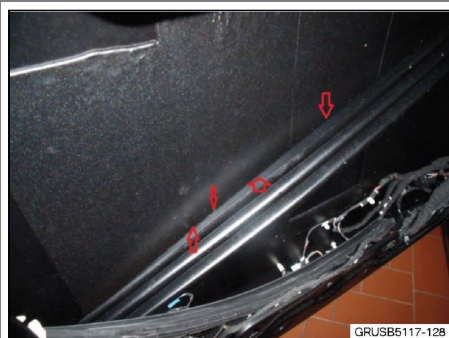
The replacement door assembly is “missing” the adhesive in the door shell between the side impact protection and outer skin.

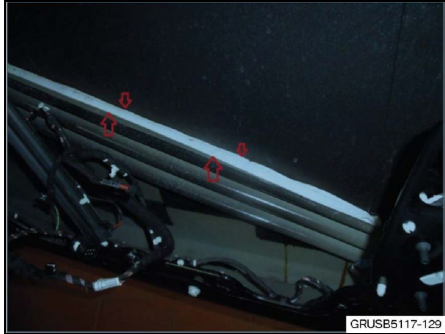
1. After consulting the vehicle maintenance history, verify the door has been replaced and is not an original factory-installed door.
2. According to the repair procedure, remove the door module carrier for the affected door: Refer to Repair Instructions – “51 33 070 Replace left front door module carrier”, or “51 33 072 Replace right front door module carrier”,
3. Verify the adhesive is missing where shown above.
4. Apply seam sealer (part # 83 42 2 409 985) where shown below.

Door assembly replacement is **not** necessary. To repair, install spreadable seam sealer at the indicated location to eliminate the vibration.

Location	Application length
Front Door	Approximately 500 mm
Rear Door	Approximately 450 mm
