### MODEL

I15 (I8 Roadster)

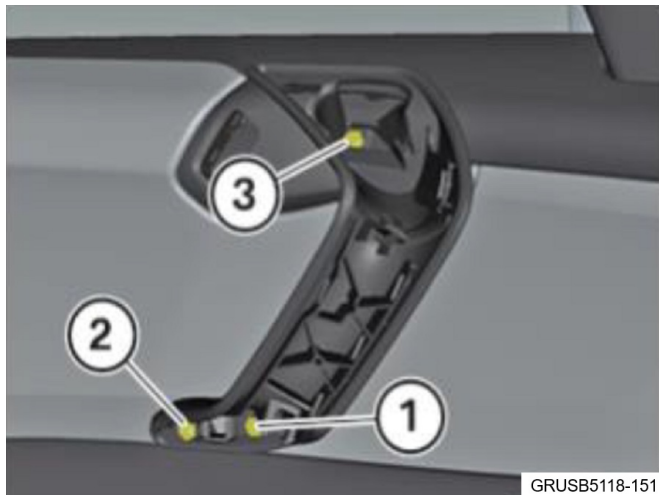
There is a groaning noise coming from the interior door grab handle when opening or closing the door.

Improper torque of the interior grab handle screws.

Loosen and re torque all 3 grab handle screws exactly to 3 Nm.
