MODEL

I15 (I8 Roadster)
Produced up to 10/2018

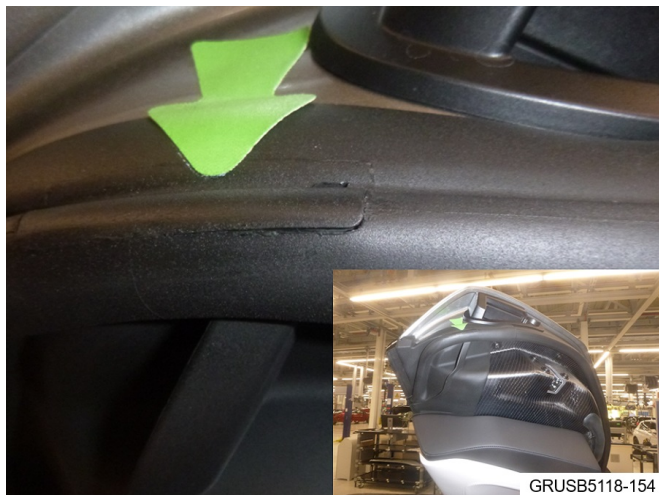
The rear section of the inner door weather strip may be separating at the bonded seam.

Insufficient bonding at the inner door weather strip seam.

If the weather strip has visible separation at the glued area as shown to the left, it will require replacement.

Following repair instructions REP 51 21 330 "Removing and installing/replacing the weather strip on the inside of the front door", replace any damaged weather stripping.
