112 (i8) Vehicles produced until August 2015.

Snow or dust may accumulate in entrance area

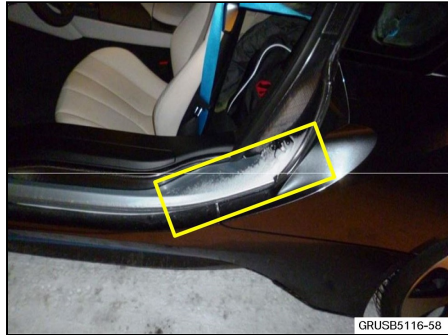
Accumulation can occur in the area shown.

Excessive clearance in door sill area.

Replace entrance cover and entrance molding on both sides.
