E-Series	Model Description
G20	3 Series Sedan

There is a whistling noise present from either front door while driving at speeds of 60 mph. This can occur on one or both front doors.

B51 25 20

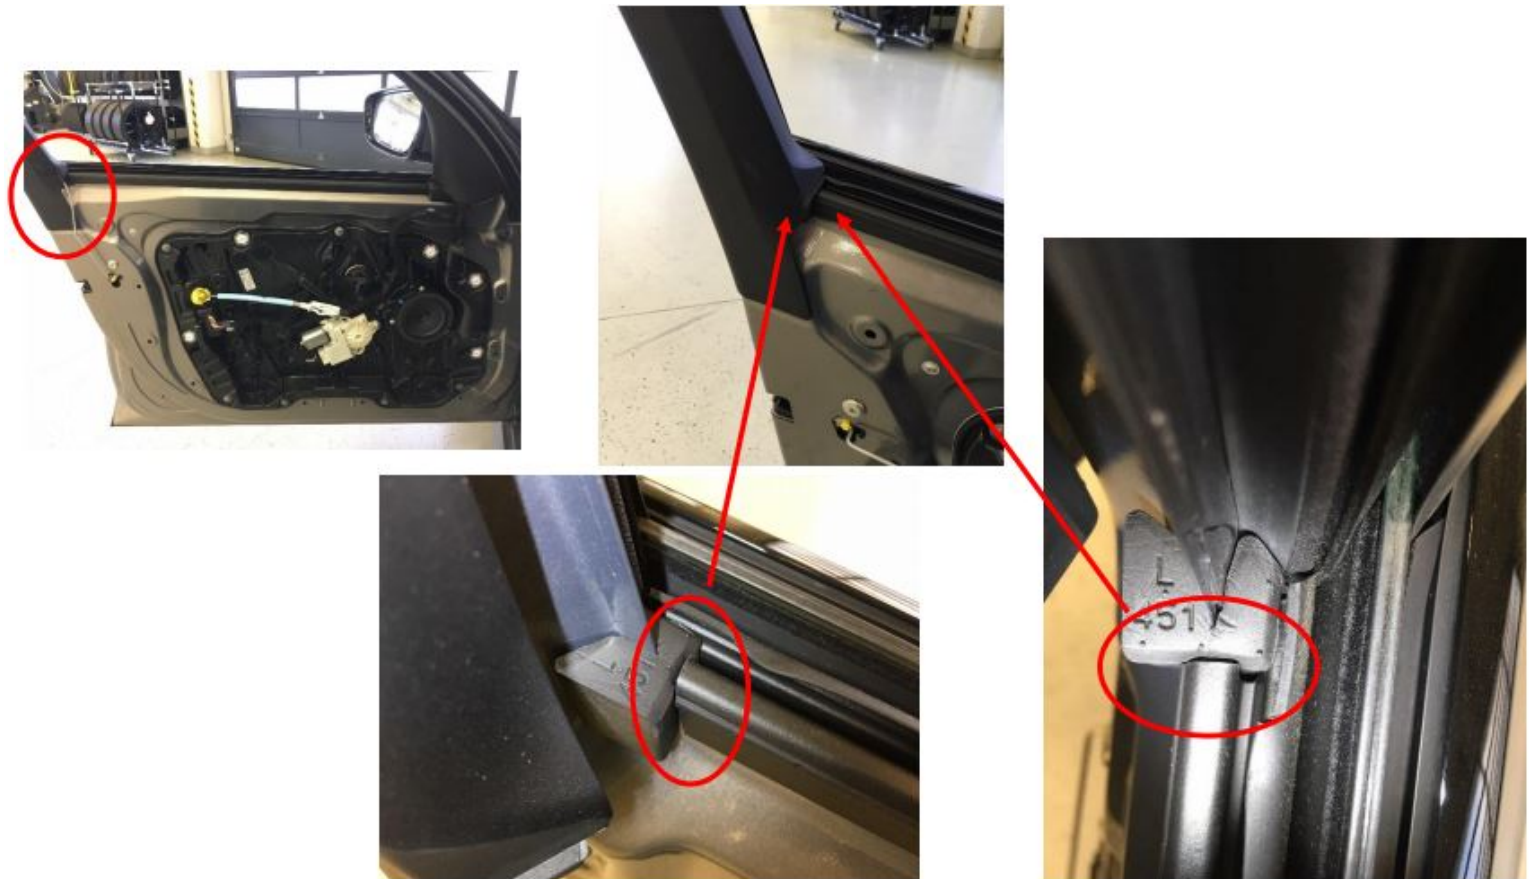
Foam acoustic seals at the A-Pillar and B-Pillar may have shrunk or shifted, causing an air leak.

1. Remove the front door panel of the affected door following repair instructions **REP 51 41 000 “Removing and installing left or right front door trim panel”**
2. Reference the photo below to identify which foam seals will be reworked. There is one foam seal at the front of the door (towards the A-Pillar) and one at the rear of the door (B-Pillar).
