## MODEL

G12 (7 Series)

GRUSB5118-158

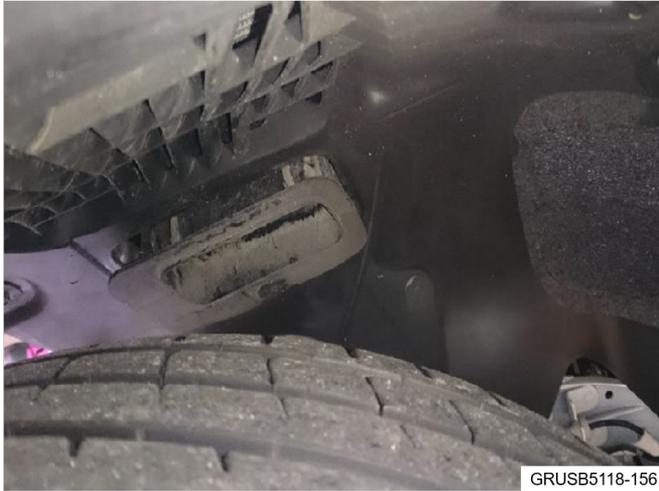
The front wheel air duct may be loose or protruding into the wheel-well as seen below.

The outer section of the air duct has separated from the inner.

Connect the two sections of air duct using an expanding rivet on one or both sides of the vehicle.

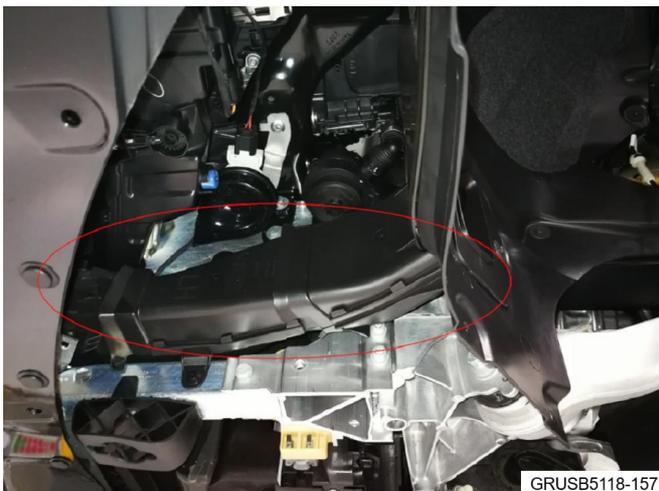
Inspect both sides of the vehicle for loose air ducts at the wheel wells.

Remove the screws attaching the underbody paneling from the affected side(s) to gain access to the air duct as seen to the left.
