E-Series	Model Description	Production Date
G20	3 Series Sedan	July 13, 2020-September 1, 2020

The rear window may not have been properly bonded.

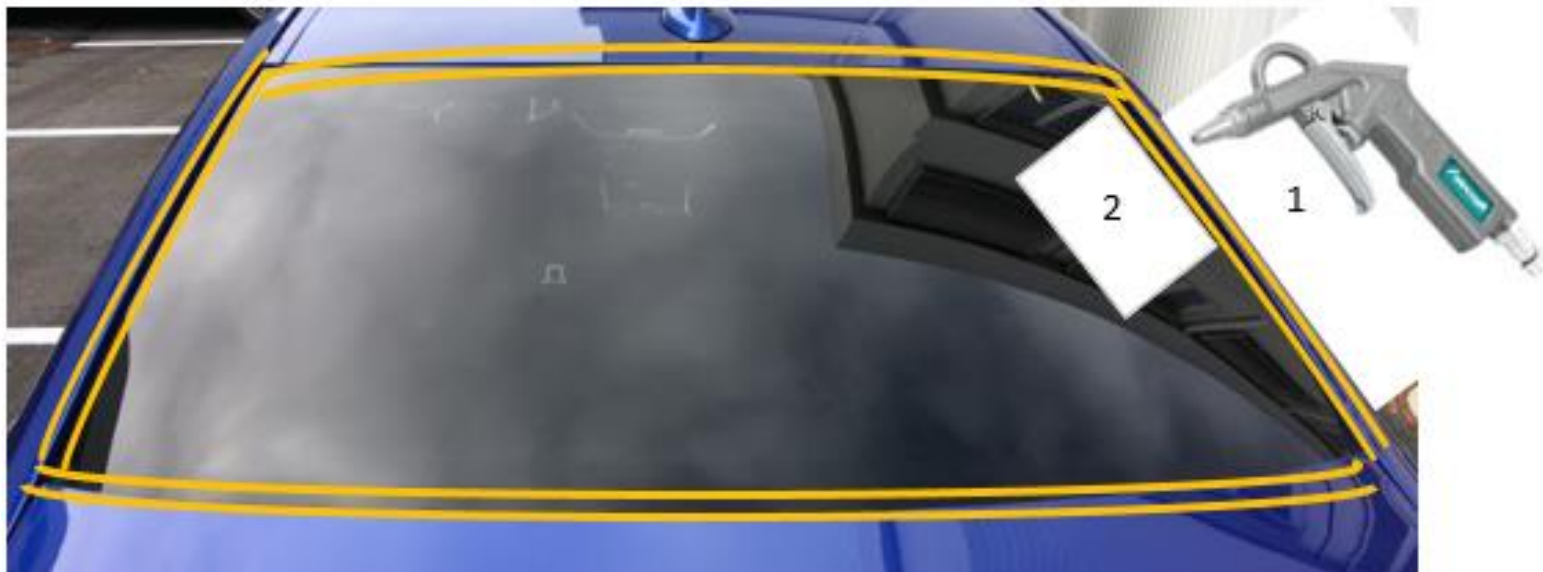
1. Using an air blow gun (# 1 below), blow air along the perimeter of the back window (aka rear windshield) towards the inside of the vehicle. Ensure the entire perimeter of the window is checked.

2. While air is being blown around the perimeter, person 2 follows along from the inside of the vehicle, moving along the back window perimeter with a piece of paper (#2 above). Movement of the paper caused by air entry indicates a leakage.

3. Re-bond the rear window following repair instructions **REP 51 31 200 “Removing and installing rear window”**.
