G30 (5 Series Sedan)			
----------------------	--	--	--

With high ambient temperatures, there is a snapping sound heard from the center of the dash area.

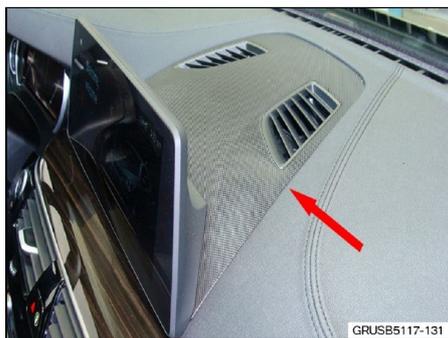
Thermal expansion/contraction of center speaker trim.

1. Remove and replace the speaker trim at the instrument panel. Refer to repair instruction in Group 51.
