EXTERIOR MIRRORS GO TO RANDOM POSITION

This Service Information bulletin supersedes SI B51 29 16 dated **December 2016**.

F48 (X1)			
----------	--	--	--

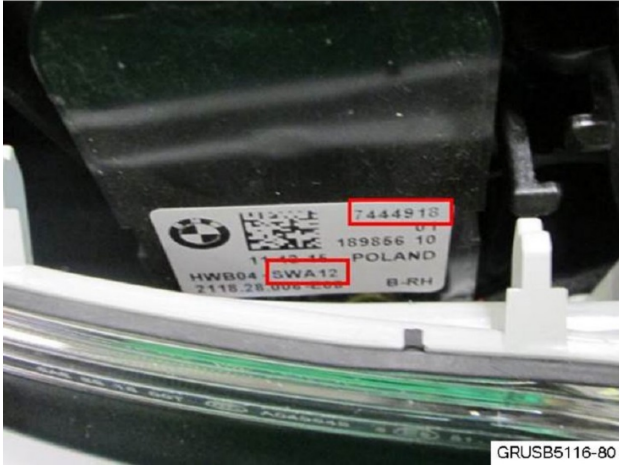
GRUSB5116-80

**Situation A-** Mirror motor electronics module software version. (Only applies to vehicles produced up until March 2016)

<b>Situation A</b>	
	<ol style="list-style-type: none"> <li>1. Verify the customer's complaint as described by the situation statement (A).</li> <li>2. Remove the cover of either the passenger's or driver's side rear view mirror and note the SWA version as shown.</li> <li>3. If the SWA version is lower than SWA12, replace both mirror electronics modules and</li> </ol>

reprogram the vehicle with the latest version of ISTA/P. Refer to RA 61 31 ... "Removing and installing or replacing left and/or right mirror electronics".

4. If the SWA version is already SWA12 or higher, do not replace the mirror electronics module.

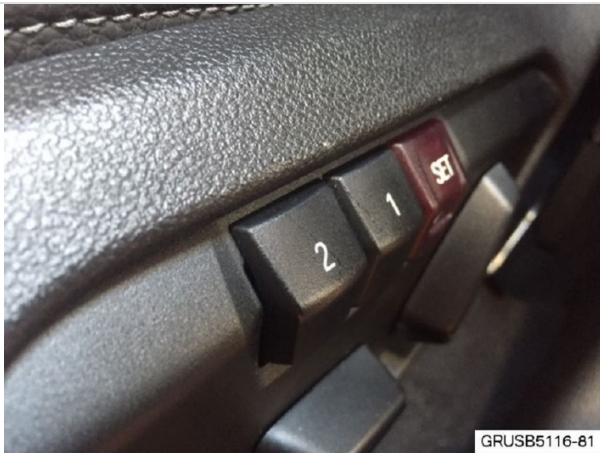
GRUSB5116-81

**Situation B-** Unintentional actuation of seat-mounted memory switch (the switch on this vehicle is mounted in a position where a customer can inadvertently press it when entering or exiting the vehicle), or the Personal Profiles settings have not been set to the customer's preferred mirror and/or seat positions .

1. Verify the customer's complaint and inform the customer of the operation of the seat/mirror memory switches and the possibility of inadvertent operation.
2. Verify that the customer's preferred seat/mirror settings are applied to the correct memory position.
