MODEL

G30 (5 Series Sedan)			
----------------------	--	--	--

At vehicle speeds above 60 mph, wind noise is heard from the vicinity of the A-pillar.

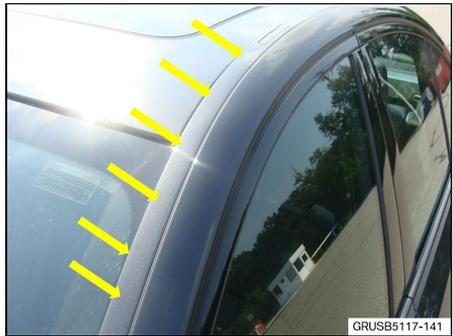
Excessive gap between the roof trim strip and the A-pillar.

<p>GRUSB5117-141</p>	<ol style="list-style-type: none"> 1. Test drive the vehicle to reproduce situation. Was noise able to be reproduced? YES- go to Step 2. NO – continue standard diagnosis 2. Obtain adhesive tape and place over the gap on the affected side and test again. Did noise go away? YES- go to Step 3. NO – continue standard diagnosis.
