RECALL 19V-755: INTERIOR TRUNK RELEASE

This Service Information Bulletin (Revision 1) replaces SI B51 35 19 **dated October 2019**.

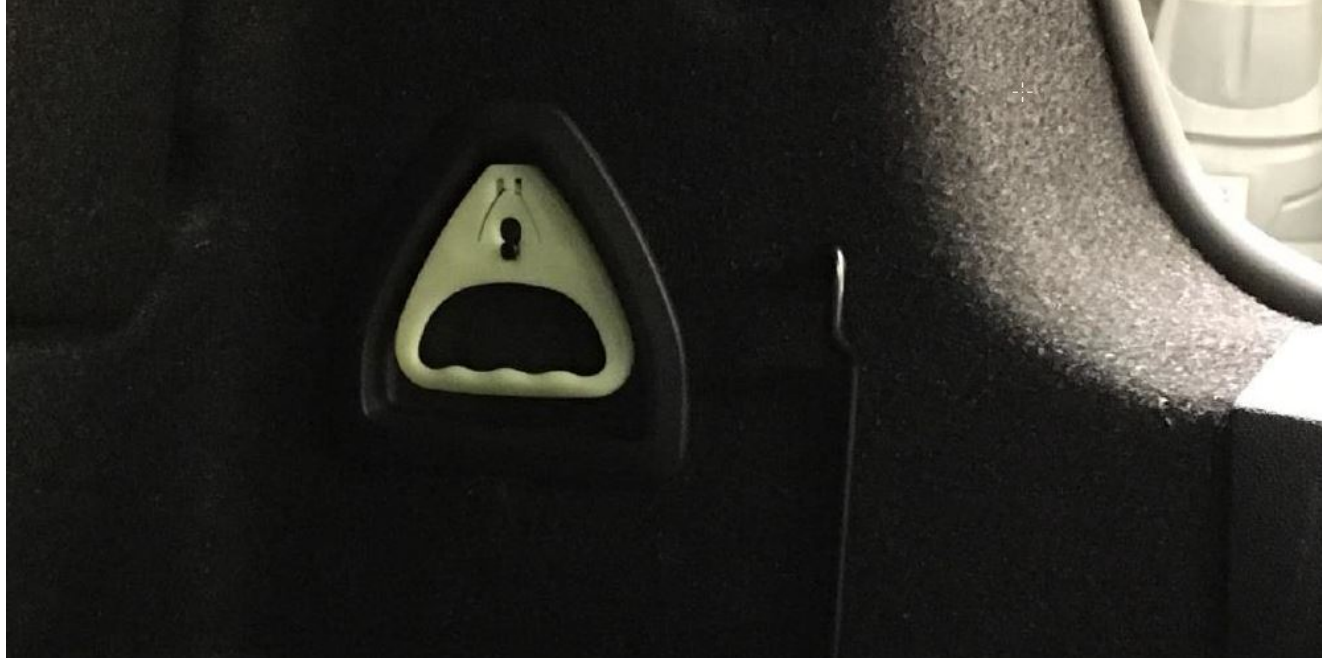
1. Open trunk lid of vehicle.
2. Manually cycle the trunk latch to the locked position while trunk lid is still open.
3. Test operation of the inside Trunk emergency unlock handle.

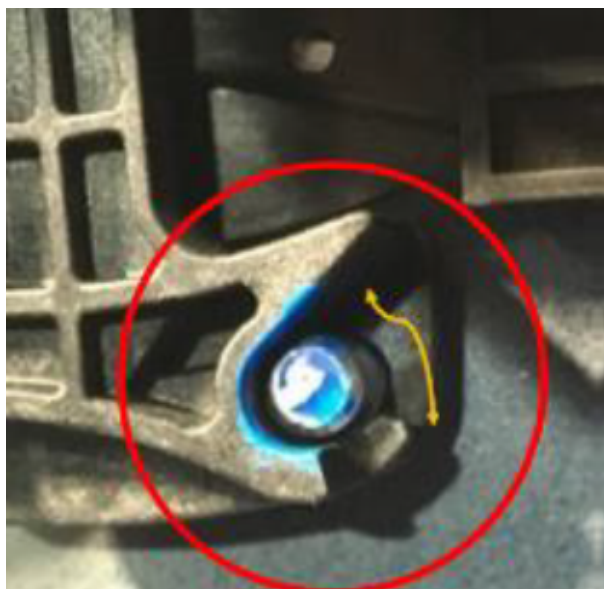
4. Does the trunk latch release?

b. No - access the trunk latch to connect the Bowden cable
