MODEL

I12 (i8)

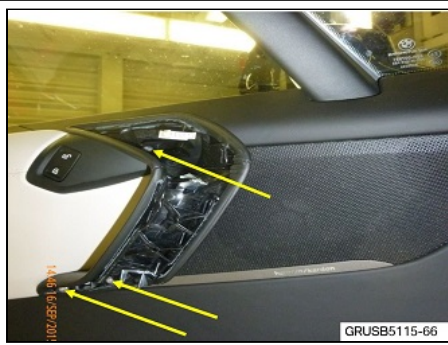
Customer states there is a cracking noise when pulling on the inside door handle.

Front door trim panel loose on right or left side.

The repair procedure shown is for the left or right door. Both front doors could be affected.

Use Repair Instruction REP 51 41 000 "Remove and install / replacing the left or right front door trim".

Retighten the three screws on the handle trim to a torque value to 2.6 Nm.

Confirm the crackling noise is gone.

If noise is still present, replace the three screws with part number 07 14 9 909 368 and torque to 3 Nm.
