DELIVERY STOP AND RECALL 19V-135: 2ND ROW SEAT CONNECTION
(Option 4U5)

This Service Information bulletin replaces SI B52 01 19 dated March 2019

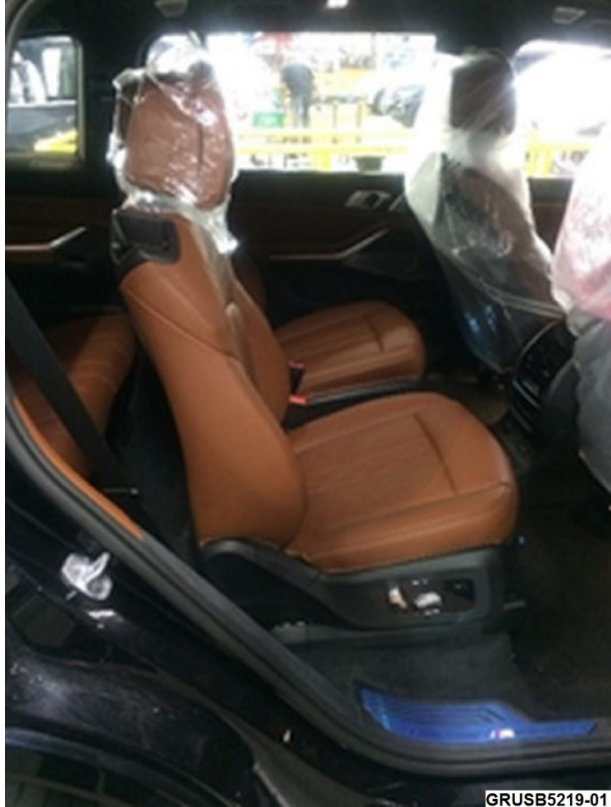
GRUSB5219-01

Move either of the second row seats fully rearward, and then raise the seat fully to its highest position as shown here (up and back).

This seat position provides clear access to the front bolts.
