**MODEL**

**SITUATION**

When getting in or out of the vehicle, a groaning noise can be heard from the opening (aperture) in the seat backrest. The noise may be heard from one or both of the front seats.

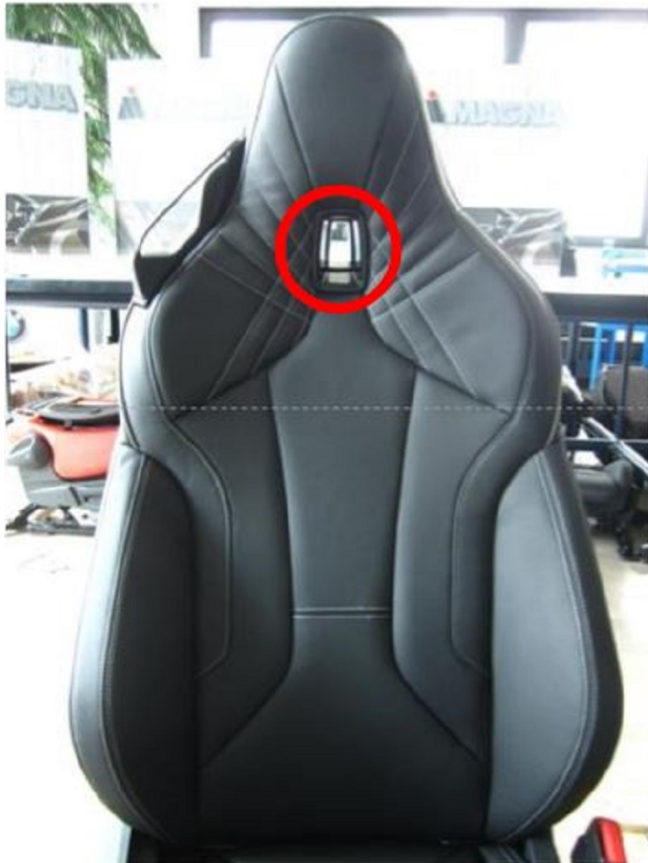
The trim aperture in the front seat is insufficiently lubricated. The front and rear halves of the trim can contact each other, causing friction noise.

Lubricate the trim aperture (circled).

### 2. Apply BMW Anti-Squeak paint to:

- mating edges of the front and rear half of the trim
- inner edges of the trim aperture
