**SEAT FAILS TO INITIALIZE DUE TO MISSING END STOP**

This Service Information Bulletin (Revision 2) replaces SI B52 01 21 **dated June 2021**.

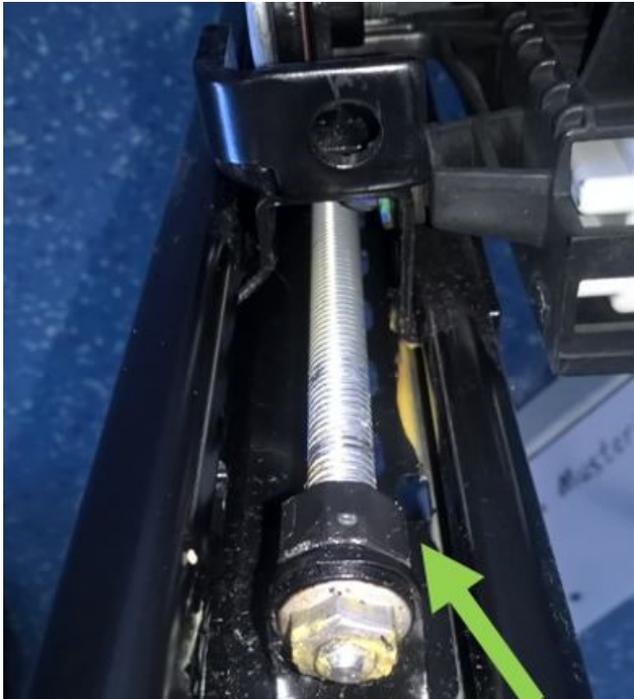
F90 G12 G30 spacer (arrow).

G30 only has a spacer installed on the passenger seat.

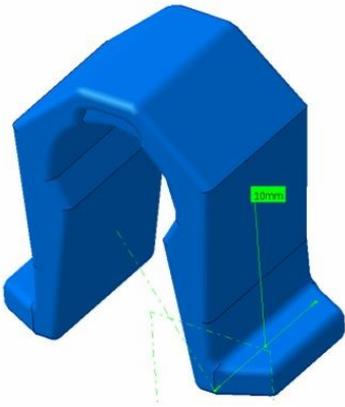
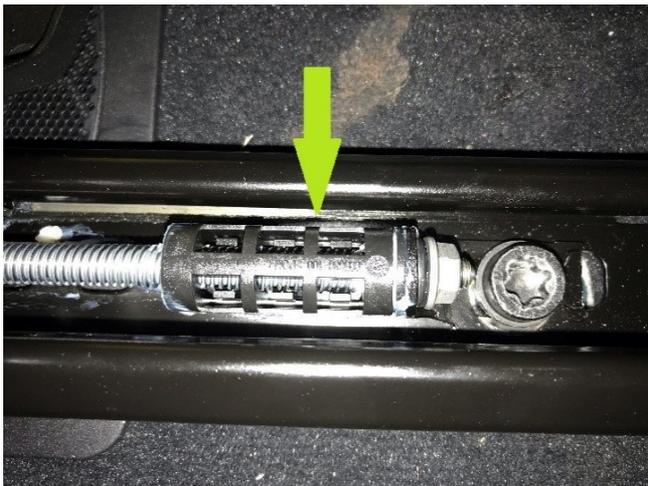
F95 F96 G05 G06 G07 spacer.

Top photo shows end stop (spacer) installed, lower photo shows rail minus the spacer.

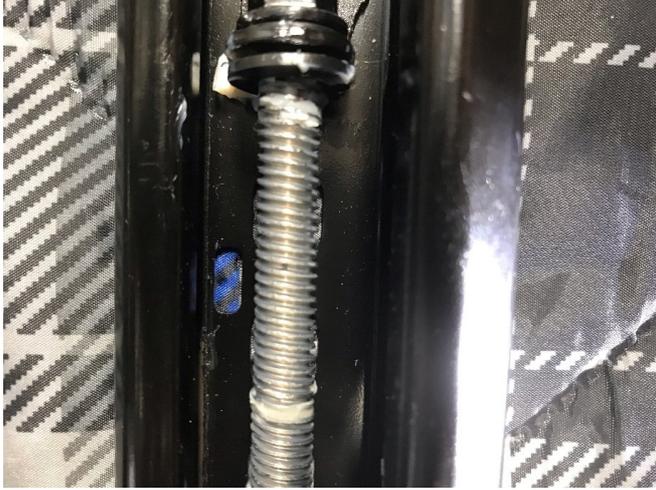
F44 spacer.

Top photo shows end stop (spacer) installed, lower photo shows rail minus the spacer.
