E-Series	Model Description
G05	(X5 Sports Activity Vehicle)
G06	(X6 Sports Activity Vehicle)

This bulletin addresses multiple customer noise complaints heard/felt in the 2nd row seats. These repairs are for the mechanical second row 60/40 Bench Seat. This includes the following concerns:

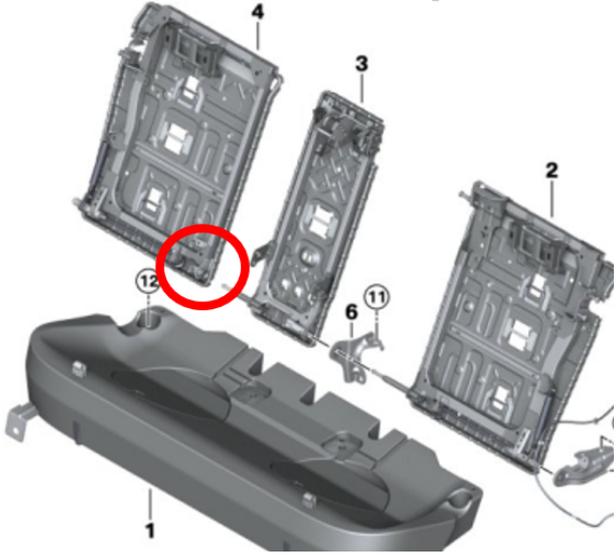
1. Missing, damage plastic bushing (white) at 40% backrest. Collision with the 60% backrest.
2. Backrest unlocking Bowden cable disengaged / damaged. Indicator for the lock visible (red).
3. Unfavorable tolerances in the lock (top, bottom) cause interference noises.
4. Trim wire has become detached from the foam structure.
5. Missing anti-groaning noise web structure at the entry sill accentuates the groaning noise.
6. Unlocking in the luggage compartment, grouting in the clutch not OK and routing of the Bowden cable is not correct.

1. Interference noise (clattering, rattling) from the 2nd row of seats, between the 40% and 60% rear seat backrest on rough road surfaces:

Disassemble 40% passenger seat to access the pivot bushing.

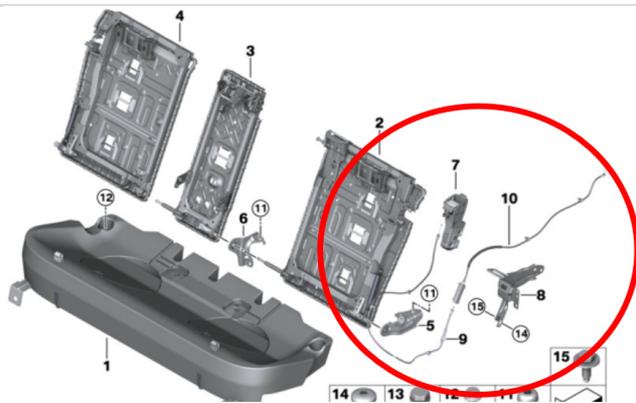
2. Backrest unlocking function does not work and causes noises:

1. Replace the damaged Bowden cable (9) and make sure that the routing of the Bowden cable is correct.

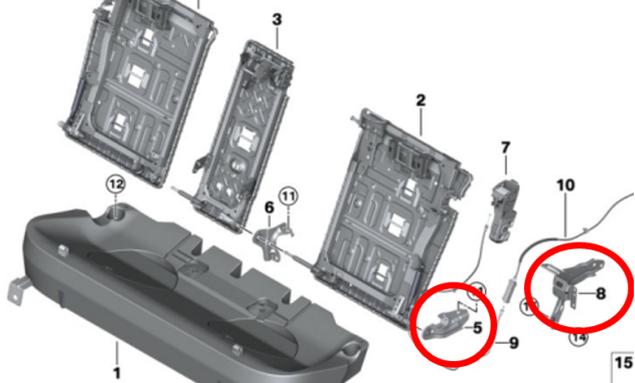
3. Backrest locking (top, bottom) rattles on rough road surfaces without load.

Replace the top and bottom lock of the backrest (5, 8).

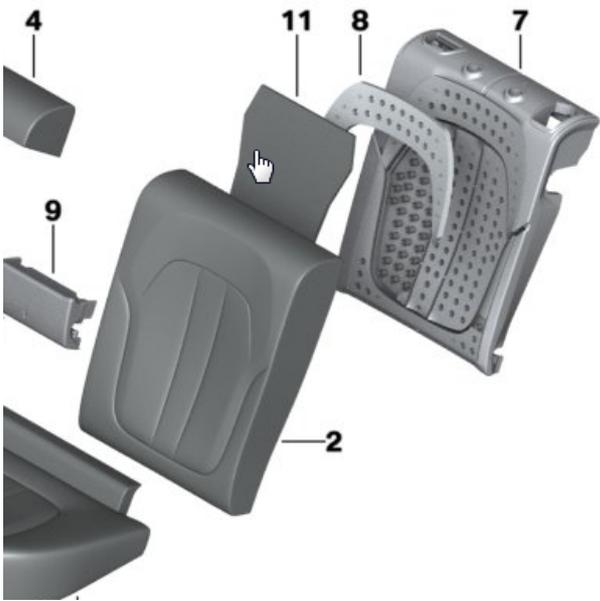
4. Squeaking noises from the rear seat bench (left and right) when loaded.

1. Remove the seat cover of the rear seat bench and replace the foam part(s) of the seat if the spring wire at the top of the seat foam is detached and visible (7, 8).

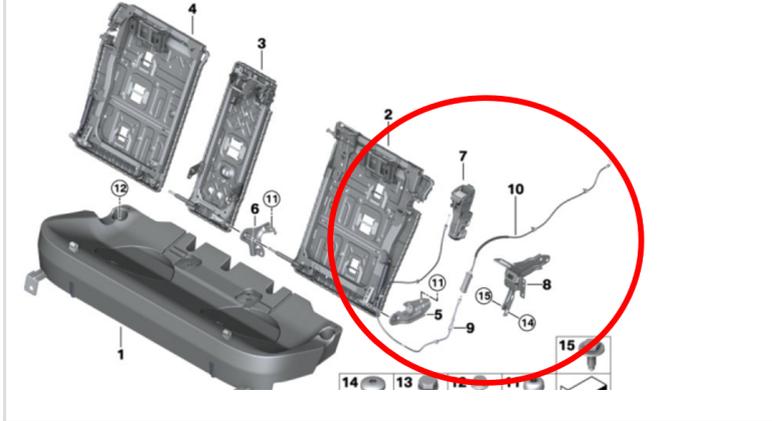
6. Unlocking in the luggage compartment, Bowden cable in the luggage compartment does not work and causes interference noises.

1. Renew the Bowden cable in the luggage compartment and ensure that it is routed correctly (10).
