**MODEL**

E-Series	Model Description	Production Date
G29	Z4 Roadster	March 4, 2021 – March 5, 2021

The seat wiring harness on the left front area of the driver's seat of the affected vehicles may have been routed incorrectly. If the seat wiring harness is routed incorrectly, it may be damaged during seat height adjustment. This could cause the adjustment functions to fail partially or completely.

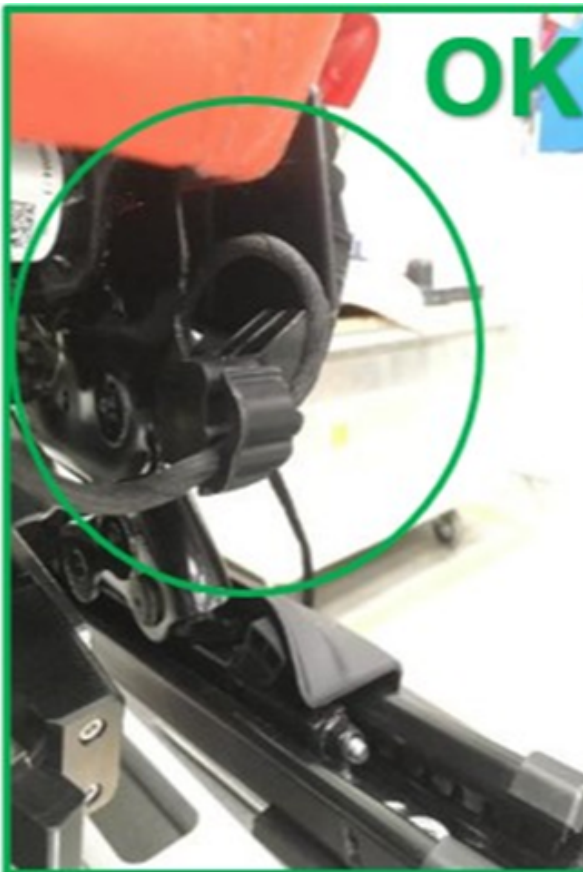
1. Check the wiring harness installation arrangement on the installed left front seat.

**If the routing of the seat wiring harness is OK, this Technical Campaign is now complete. Replace no parts.**

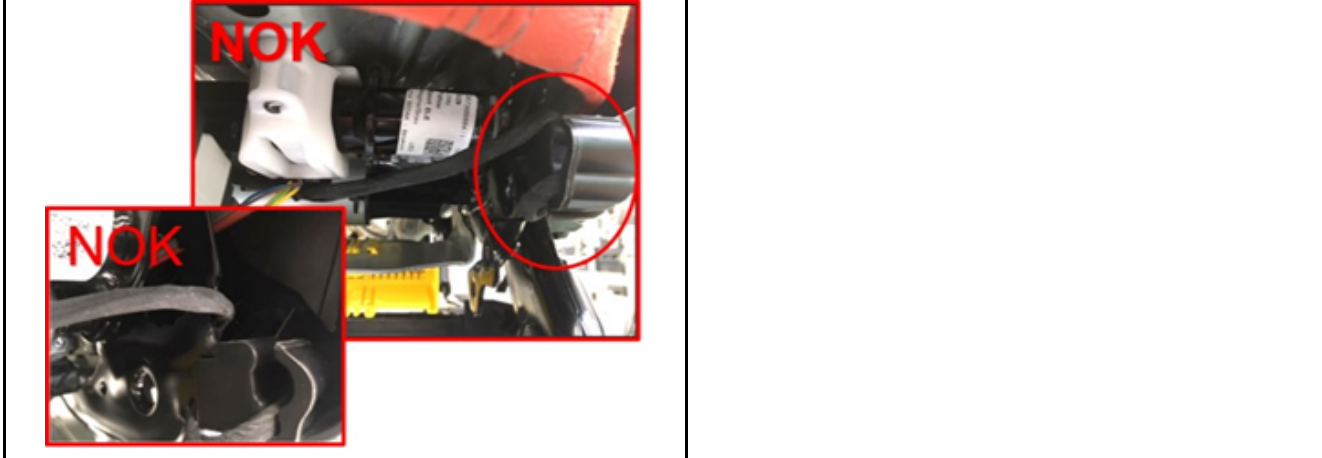
2. If the routing is incorrect (NOK stands for not OK), continue to **step 3**.

3. If the routing of the seat wiring harness is faulty, remove the left seat according to Repair Instructions 52 13 001 Removing the driver's seat.

**If the wiring harness is not damaged**, then route the wiring harness correctly in accordance with the attached repair instructions (Harness Routing). **The Technical Campaign ends here; replace no parts.**

4. **If the seat wiring harness is severely damaged**, it must be replaced in accordance with the attached repair instructions (Damaged harness).
