This Service Information Bulletin (Revision 2) replaces SI B52 08 21 **dated August 2021**.

BMW AG is conducting a Voluntary Safety Recall (effective July 8, 2021) on a small number of Model Year 2018 - 2019 BMW vehicles that were produced between December 4, 2017 and June 3, 2019.

Replace the front passenger seat cushion which contains the CIS mat.

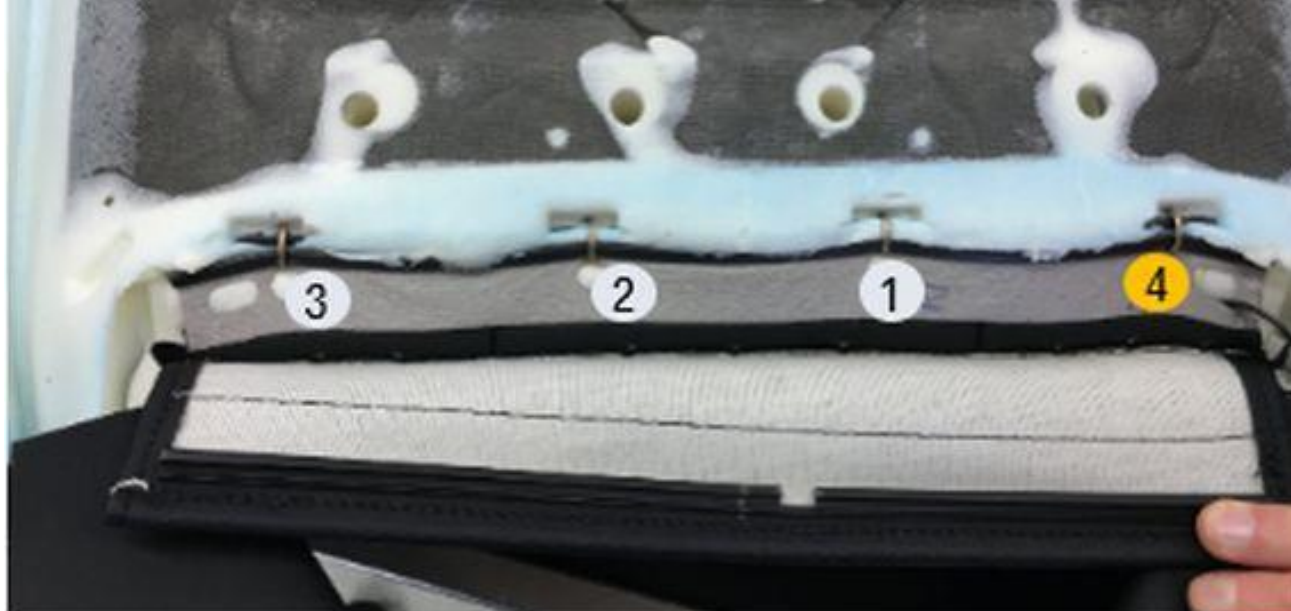
Due to an incorrect mounting of the seat cover, one or more of the hog rings (clamps) could contact the seat heating cable harness near the area of the seat cushion and thigh support. Over time, this could affect CIS Mat functionality. Hog rings are small metal clamps which fasten the seat cover to the seat frame.

New: The sequence in which the hog ring clamps are installed must be observed.

First clamp items 1-3, then clamp the area of the cable outlet 4 to prevent the seat heater line from being contacted and/or damaged by clamps.

3. After reinstalling the seat cover, the seat occupancy mat (CIS) must be released with ISTA service function:
- Procedure Front passenger seat occupancy detection, US version (ABL-WAR-AT6577_SBE4I5US3)
