THIGH SUPPORT UPHOLSTERY DETACHES FROM SEAT

This Service Information Bulletin (Revision 3) replaces SI B52 10 19 **dated January 2020**.

E-Series	Model Description
G05	X5 Sports Activity Vehicle
G06	X6 Sports Activity Vehicle
G07	X7 Sports Activity Vehicle

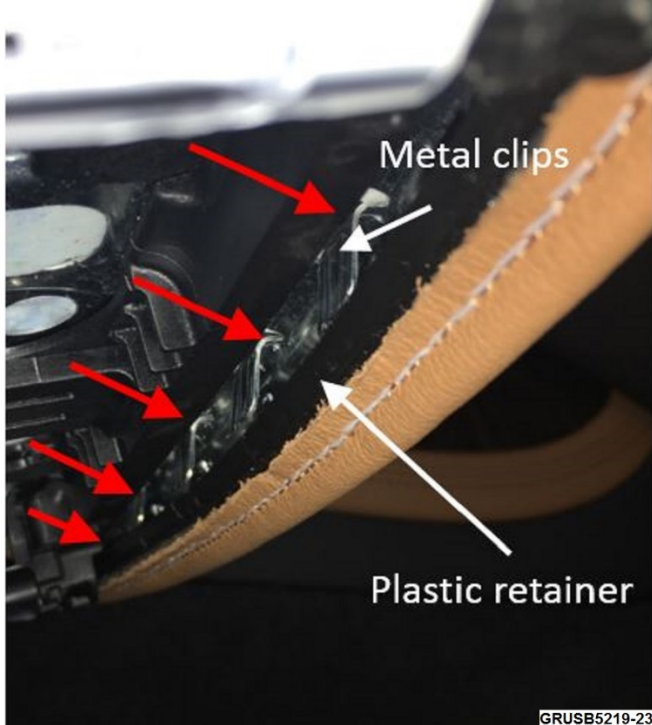
GRUSB5219-23

<p>2. <b>Incorrect:</b> Retainer and trim are not properly installed (red arrows).</p> <ul style="list-style-type: none"> <li>• The edge of the leather seat upholstery is sewn onto a plastic retainer strip</li> <li>• The retainer strip is supposed to be held in place by the firm contact of the 5 metal clips</li> </ul>
--	---

Bend the 5 metal clips as needed to retain the upholstery as shown below in step 6.

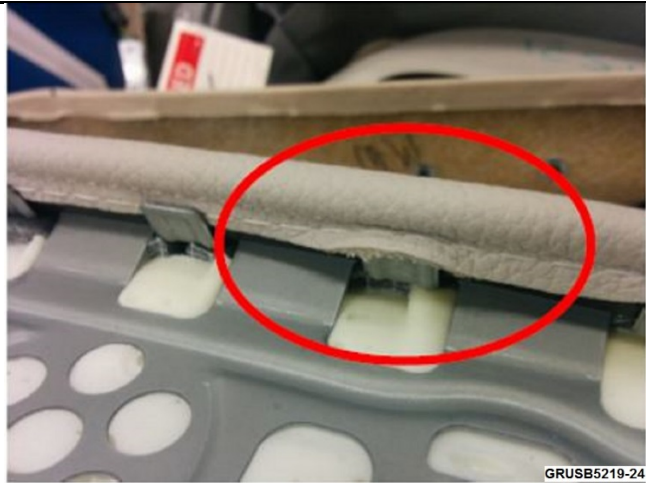
GRUSB5219-24

3. **Incorrect:** Retainer and trim not properly installed-
- Left clip too loose against retainer
  - Leather is overlapping the right clip (circled) so that the clip cannot press against the retainer

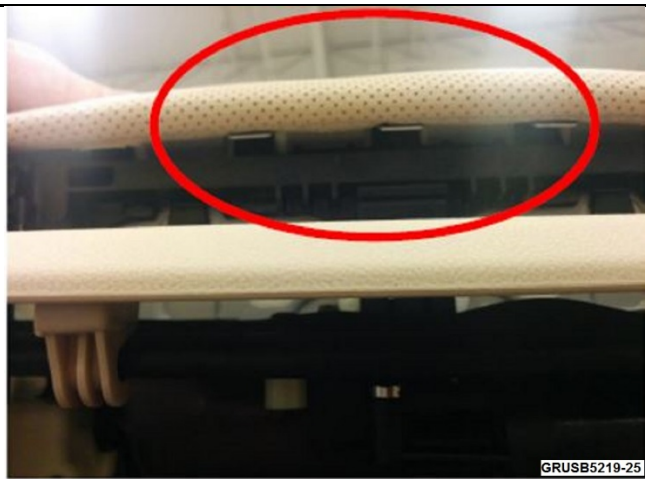
GRUSB5219-25

4. **Incorrect:** The metal clips (circled) are not exerting enough force against the retainer strip.
- Slight gaps are present between the clips and the retainer strip

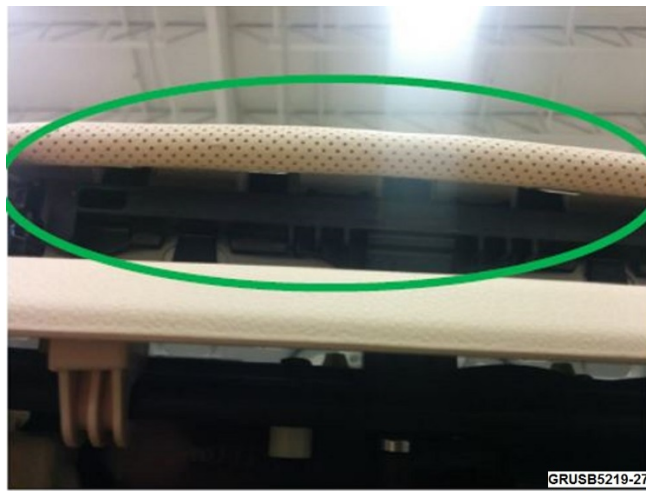
**6. Correct:** Retainer and trim placed correctly inside the metal clips.

- Clips are firmly pressed against the trim
- No gap exists between the trim and metal clips

Note: Bend the 5 metal clips as necessary.
