Model

G29 (Z4 Roadster)			
Produced until 3/6/2019

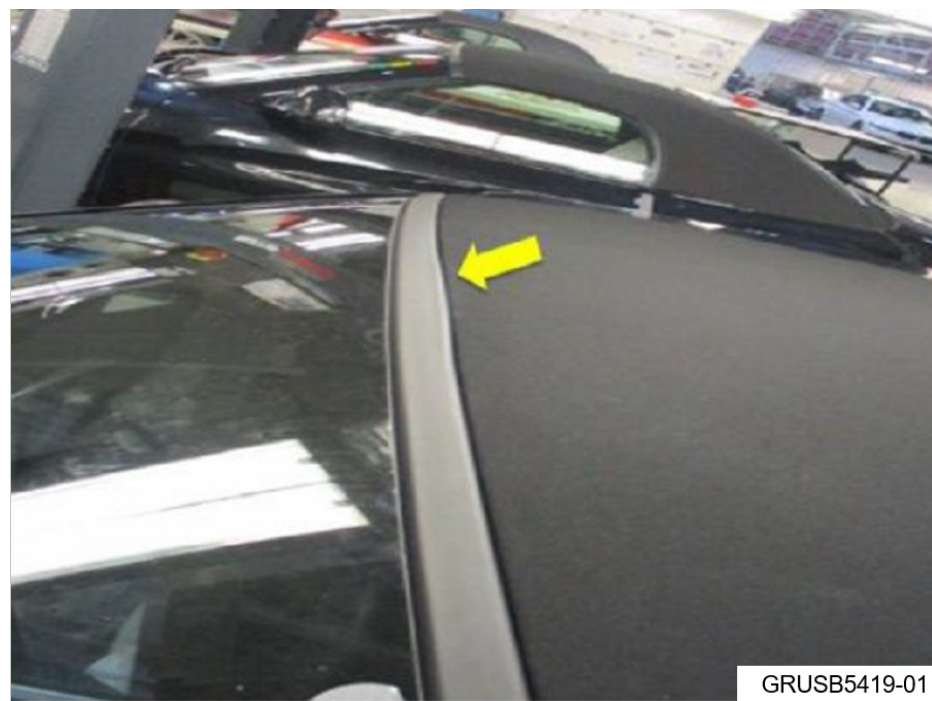
The upper windshield cowl panel seal may appear deformed as shown below:

The seal was not fully seated during installation, allowing the convertible top to press the seal out away from the windshield when closed.

Ensure the seal is completely seated.

1. Open the convertible top to allow access to the top of the windshield sealing area.
1. Press down firmly on the seal to ensure it presses completely into the windshield cowl panel. Verify the appearance is uniform across the entire length of the windshield.
1. Completely close the convertible top. It is suggested to leave the convertible top closed for 24 hours to ensure the seal correctly seats into the windshield cowl.
