## SUNROOF REVERSES WHEN CLOSING

E-Series	Model Description	Affected Option Code
G12	7 Series Sedan	Without 402 (Panoramic moonroof)

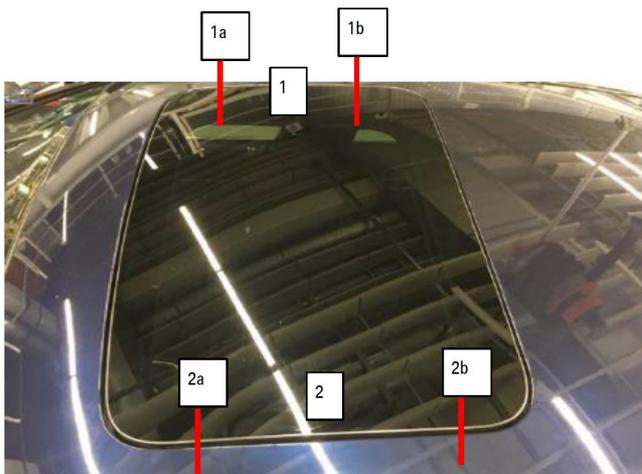
2. Measure the gap between the sunroof glass panel and the roof as shown at 6 points 1a, 1b, 1c, 2a, 2b, 2c.

Gap 1a should match gap 2a.  
Gap 1 should match gap 2.  
Gap 1b should match gap 2b.

If the gaps measure differently side to side, continue to step 3. Otherwise, continue to step 5.

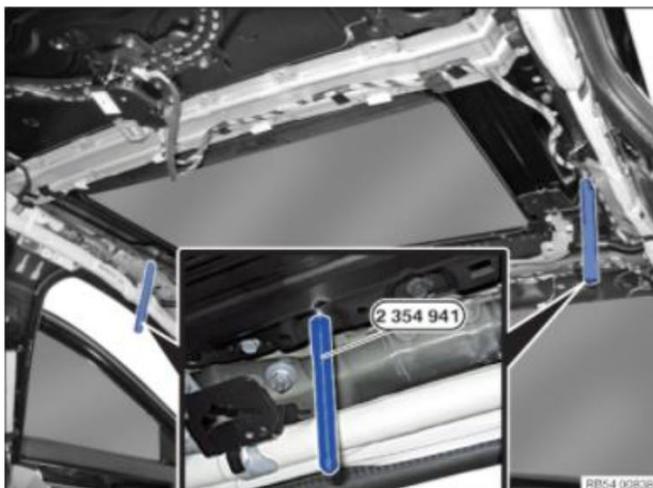
3. Lower the headliner to check the position of the sunroof frame using alignment tool 2 354 941 as shown.

Note: The alignment tool will insert vertically, without tilting, if the sunroof frame is correctly aligned.

Ensure the alignment tool fits easily and completely into the alignment bores. If the tool does not align correctly in the frame, loosen the frame bolts, adjust the frame as necessary, and torque the bolts to 9.5 Nm.

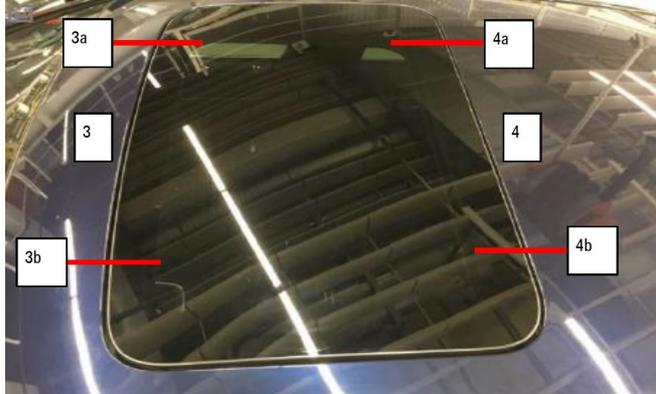
5. Similar to the measurements taken in step 2, compare the gap measurements at the front and rear of the glass.

Gap 3a should be 1 mm smaller than gap 4a.

Gap 3 should be 1 mm smaller than gap 4.

Gap 3b should be 1 mm smaller than gap 4b.

If the gaps are incorrect, adjust the sunroof glass panel following repair instructions **REP 54 12 003 “Adjusting glass slide/tilt sunroof panel”** and continue to step 6. If the gaps are correct, continue to step 6.
