# MODEL

G01 (X3) produced from 9/11/2017-1/15/2018		
--	--	--

# SITUATION

The panoramic sunroof may not be functioning, or may be causing noises during operation from the area of the roof function center (FZD).

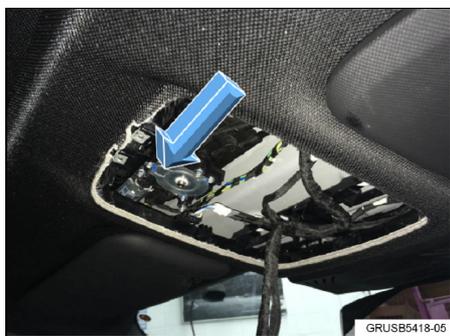
2. Inspect the identification label number on the sunroof drive motor. The identification number is located in the top right corner of the label as shown.

3. Does the number on the identification label contain **6 or 7 digits**?  
**6 digits:** This bulletin **does not apply**, continue normal diagnosis of the panoramic sunroof.

**7 digits:** Replace the sunroof drive motor, following repair instruction **REP 67 61 580 Replacing the drive for the glass slide/tilt sunroof panel.**
