E-Series	Model Description
G23	4 Series Convertible

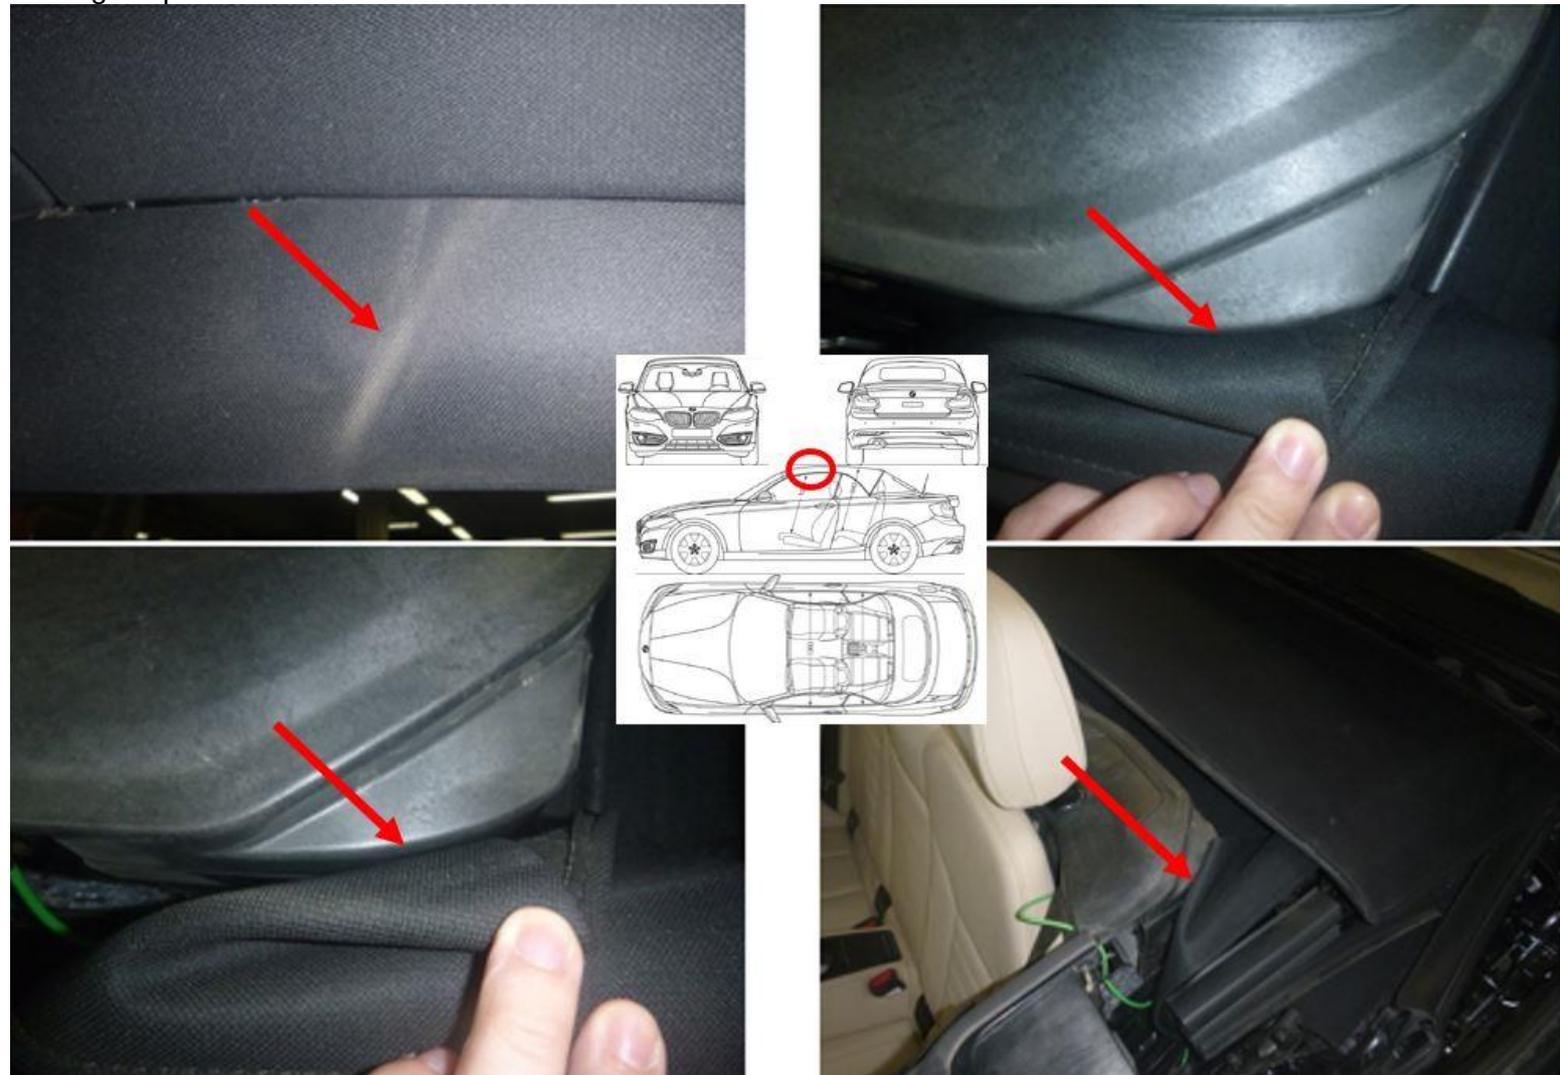
Damage is present on the headliner in the area shown below. This can occur on one or both sides.

Smooth the sharp edges of trim/body which are causing the damage. Replace the front headliner.

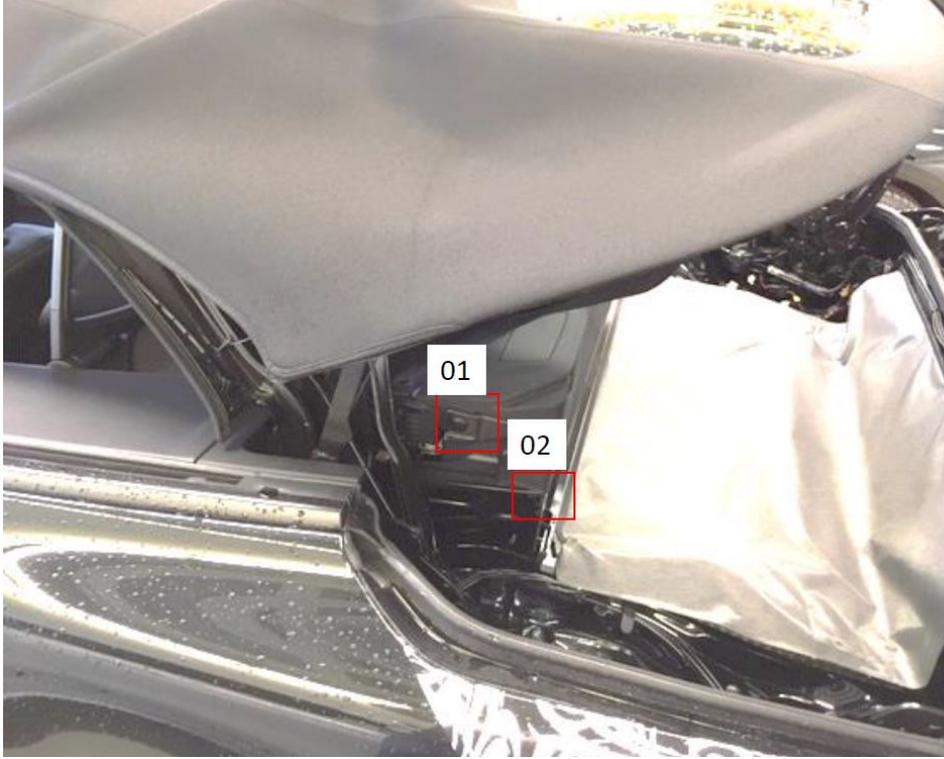
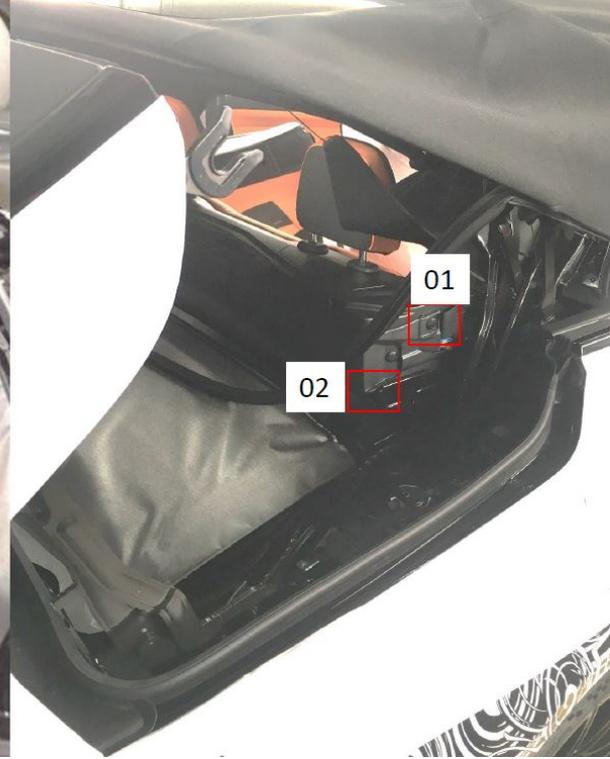
The headliner is rubbing against a sharp edge of the trim and body at points 1 and 2.

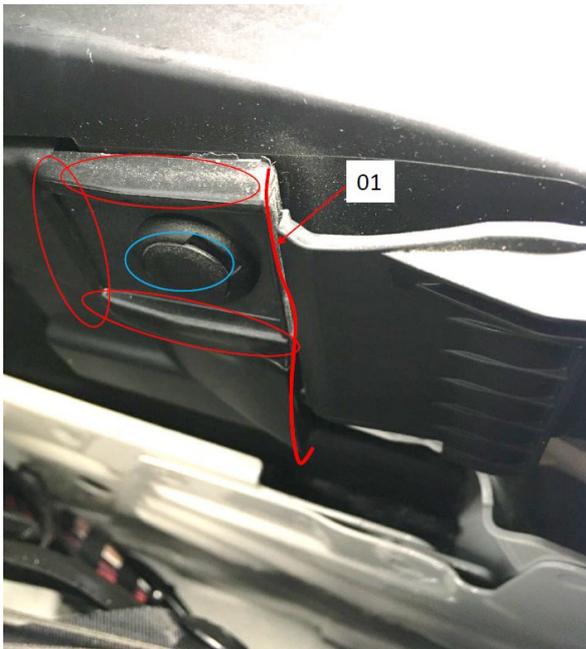
1. Inspect area 1 shown to the left for signs of burrs or sharp edges (red lines).

- Smooth any sharp edges of the trim using a file or sandpaper.
- If the expanding rivet (blue circle) has any burr or sharp edges, replace it using PN 07 14 7 401 727.

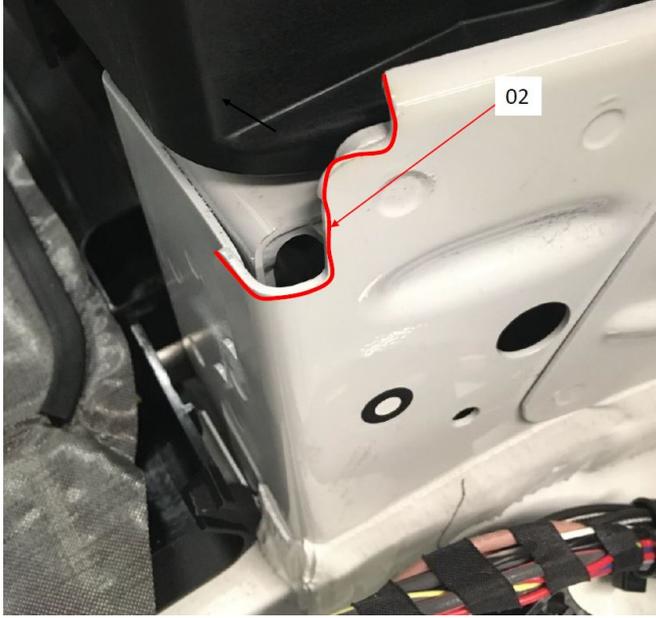
2. Inspect the body in area 2 for any sharp edges or burrs. If found, smooth the sharp edges using a file.

Note: If smoothing the edges results in going completely through the paint finish to metal, you must touch up the paint using the applicable color paint touch up stick.

3. Replace the front headliner following repair instructions **REP 54 34 131** “Remove and install/replace both front headlinings”.
