This Service Information bulletin supersedes SI B54 04 14 **dated April 2014**.

| E89 (Z4) |

The wiring harness for the convertible top rear module sensor may be positioned incorrectly, which can cause damage to the wiring harness.

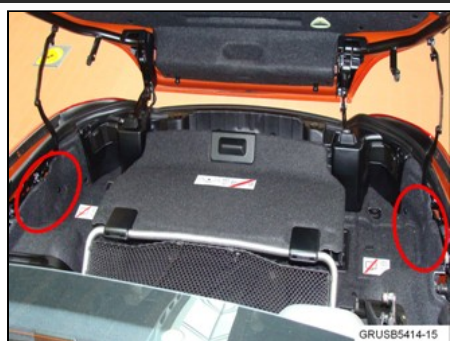
1. The areas to be worked on are highlighted by red circles.

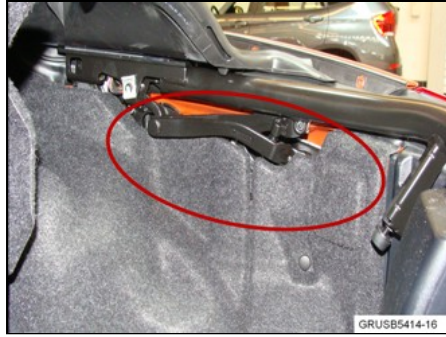
2. A closer view of the area that needs to be inspected is highlighted in red.

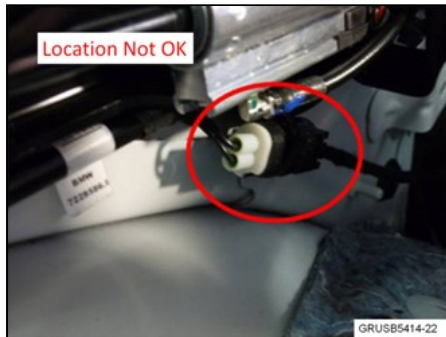
14. This picture shows the sensor connector for the "Rear module closed" sensor incorrectly positioned.
15. Remove the cable tie holding the connector in place.
16. Inspect the sensor wiring harness for damage. If there is no damage, relocate the connector to the position shown in the next picture below.
